“KEEPING PACE” - #12

TANKER TRUCK EXPLOSION:

SEWER GAS EXPLOSION:

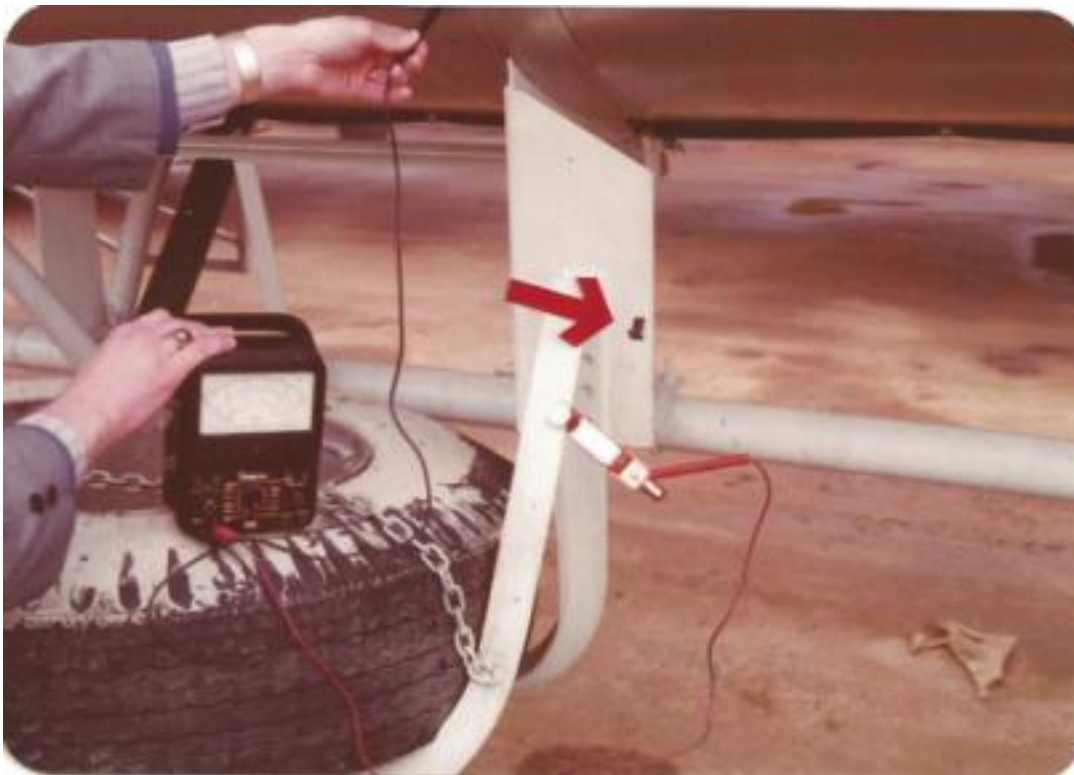
The photograph below shows a portion of a semi-tanker truck, identical to one which exploded and burned while being filled with a flammable liquid, in Memphis, Tennessee. The driver who was standing on top of the tanker was blown off and badly burned. My investigation revealed that the workmen had negligently and routinely been connecting the static discharge grounding wire to painted surfaces on the trucks, rather than to unpainted surfaces, which were harder to find. A painted surface is an effective insulator, and thus, the static electricity caused by the filling operation could not discharge through the grounding wire to ground. Therefore, the static electricity built up until it eventually flashed over and ignited the fumes from the flammable liquid. The arrow in the photograph below points to an area on the painted surface of a similar truck, where the paint has been worn away by the alligator grounding clips over a period of time. In this explosion, as in most explosions, it was impossible to determine the exact location of the spark which ignited the fumes from the flammable liquid.

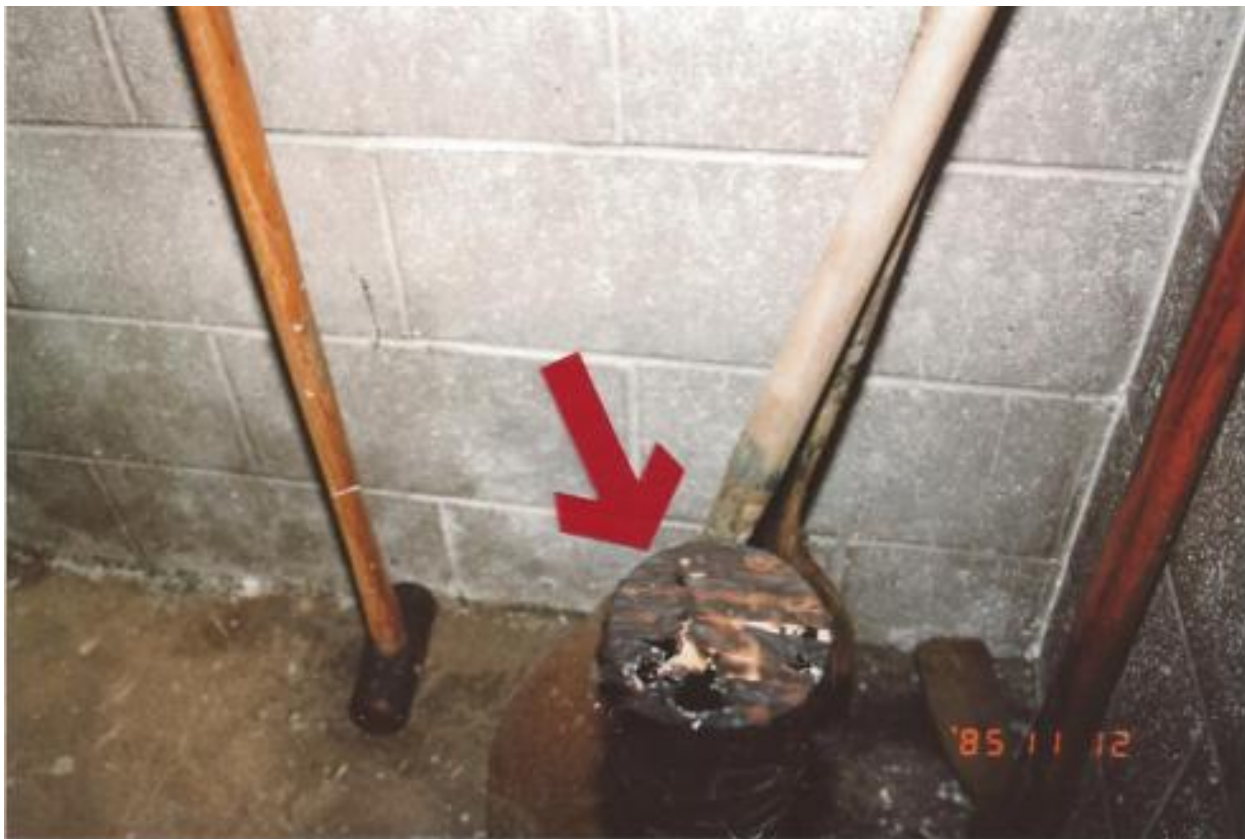
The next photograph shows the source of an explosive gas where the source of ignition may have been a tool being used by a workman to scrape a concrete floor. The cause of this explosion was a mystery until I discovered that the sewer line from this new building had no trap in it to prevent sewer gases from entering the building. Rather, the top of the drain pipe had simply been taped, as shown in the photograph. Thus, it was sewer gas which exploded and subsequently damaged this building and seriously burned the workman.
