## “KEEPING PACE” - #13

### VENT PIPE CLEARANCES:

### ALUMINUM WIRING: (Revised):

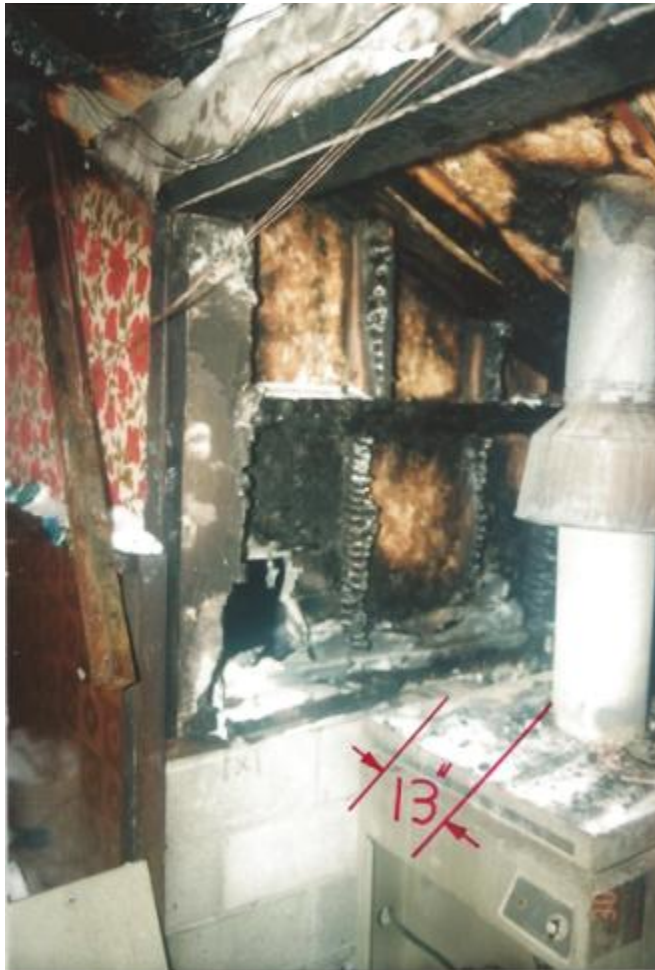
The above photograph shows the only low burning which occurred in a building which housed a residential swimming pool in Edinboro, Pennsylvania. The gas water heater shown in the photograph was used to heat the swimming pool water. Even though the 2x4's at the adjacent wall were 13" away from the single wall vent pipe, after a few years one 2x4 eventually was ignited by the heat emanating from the vent. There was no other source of heating power in this area and after the fire the gas water heater still functioned properly. The B.O.C.A. code specifies that all combustible materials must be kept at least 18" away from single wall vent pipe sections located below a draft diverter and 6" away from vent pipe sections located above a draft diverter. Paragraph M1210.3.4 and Table M1215.4.7 of the 1984 B.O.C.A. Basic National Mechanical Code specify these dimensions.

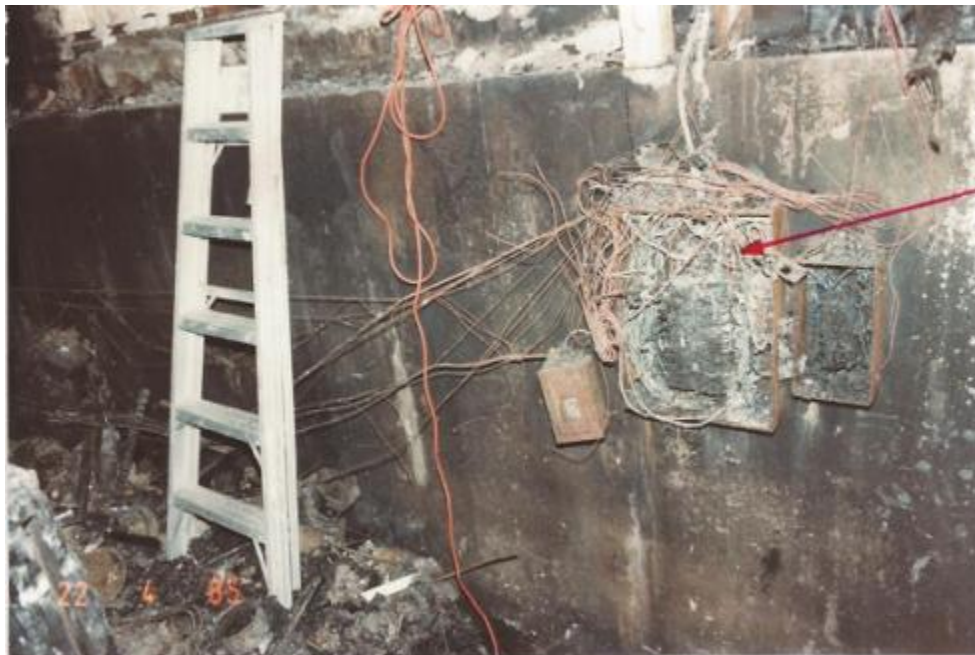
The photograph above shows a circuit breaker panel where a high resistance aluminum cable service entrance connection totaled a home in Detroit. Such fires occur because aluminum oxide is not a conductor as copper oxide is. As the aluminum expands and contracts, the connection becomes slightly loose, increasing the electrical resistance (ohms) at the connection as the aluminum corrodes. The high electrical currents passing through this main connection, in combination with the heightened resistance, create heating, which eventually leads to significant arcing. The series arcing can then grow to create parallel arcing, or a short circuit between the hot lead and the neutral lead or the other hot lead (short circuit). The initial high resistance connection is often termed a “series fault”, because the fault is in series with the load. A parallel fault, or short circuit, is usually in parallel with the load. The parallel fault is capable of much greater arcing energy.

In 1986 these series faults at the circuit breaker panel accounted for 1% of fires. Since then, electricians have been trained to use an “Anti-Oxidant” cream at these connections. That has greatly reduced these fires.
