## “KEEPING PACE” - #20

### MORE ON LATENT DEFECTS:

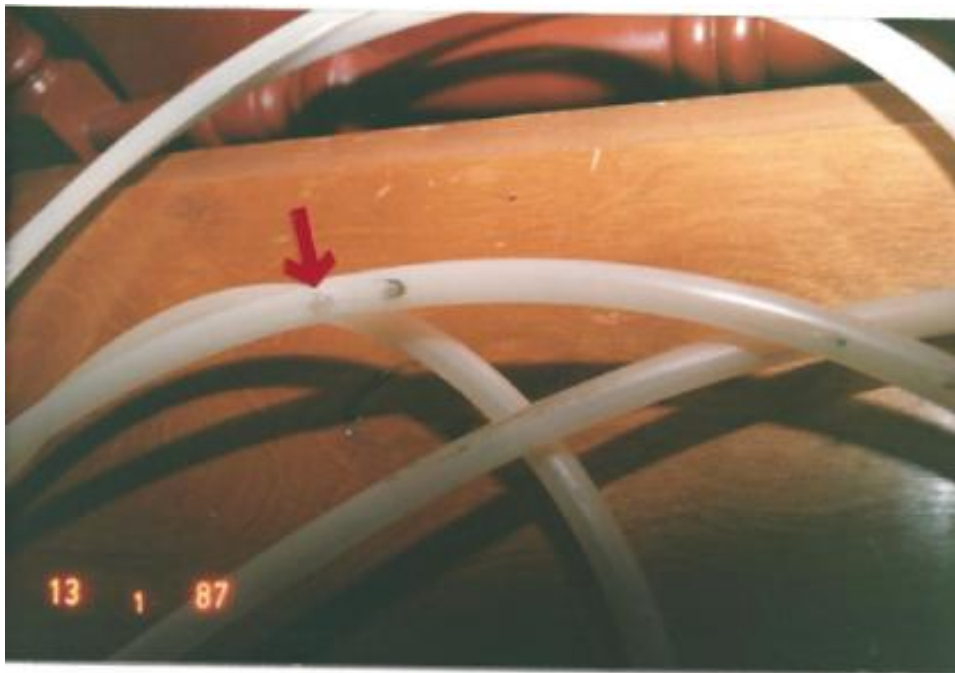
In “KEEPING PACE” - #16, we discussed how plastic electrical insulation can take a long time to break down into a short circuit (kind of a current leak) after it is damaged. The photograph below shows a section of plastic water tubing which was damaged by being pulled against the sharp edge of a furnace vent when it was installed in the attic of a home. A water leak did not develop until seven years later, when the plastic wall of the tubing finally degraded enough to open. That resulted in a small insurance claim for flooding. This is another example of how a latent defect in plastic can take years to manifest itself.
