## “KEEPING PACE” - #21

### UNUSUAL FIRE:

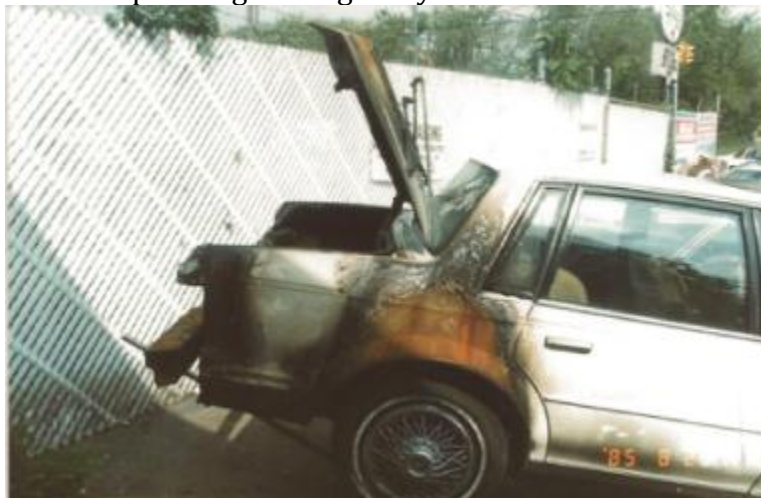
As he was pulling into his own driveway, the driver gunned the engine of the automobile shown below. A fire immediately broke out at its rear for no apparent reason. P.A.C.E. tests showed that there was no leak anywhere in the fuel system. There also was no short circuit melt in the few wires at the rear of the car. Neither was there enough combustible insulation there to cause this much damage. So what was the cause? Arson came to mind, but the driver of the car is a sales agent for the insurance company. P.A.C.E. could only conclude in its report that a quantity of gasoline had been pushed out the end of the exhaust pipe when the engine was gunned, and that the engine should be examined again after repairs were complete. When the engine was started after these repairs, another (small) fire developed at its carburetor. This confirmed our opinion that the fuel system and exhaust system were operating while greatly overloaded with fuel.

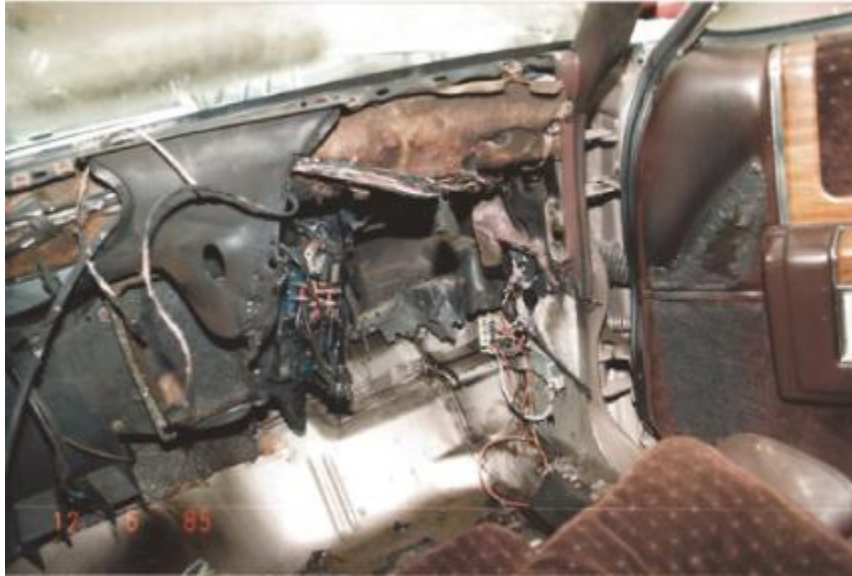
### SHORT CIRCUIT FIRE IN DASHBOARD

The next photograph shows the remains of an obvious dashboard short circuit fire. As in about 2% of our vehicle short circuit cases, the energy expended by the short did not leave a melt anywhere on the electrical conductors. We included this information in our report and the manufacturer still paid 100% of the claim. P.A.C.E. has obtained a copy of a letter whereby this same manufacturer states that they are able to start vehicle short circuit fires without popping a 20 ampere fuse. In the opinion of P.A.C.E, using a 10 ampere fuse in place of a 20 ampere fuse in new designs would not just reduce the available short circuit heating energy by two, or four times, but rather by a factor of hundreds. We will be trying to publish our supporting data for this opinion in the near future, and we will be trying to encourage manufacturers to reduce the size of their fuses, many of which are needlessly large anyway.

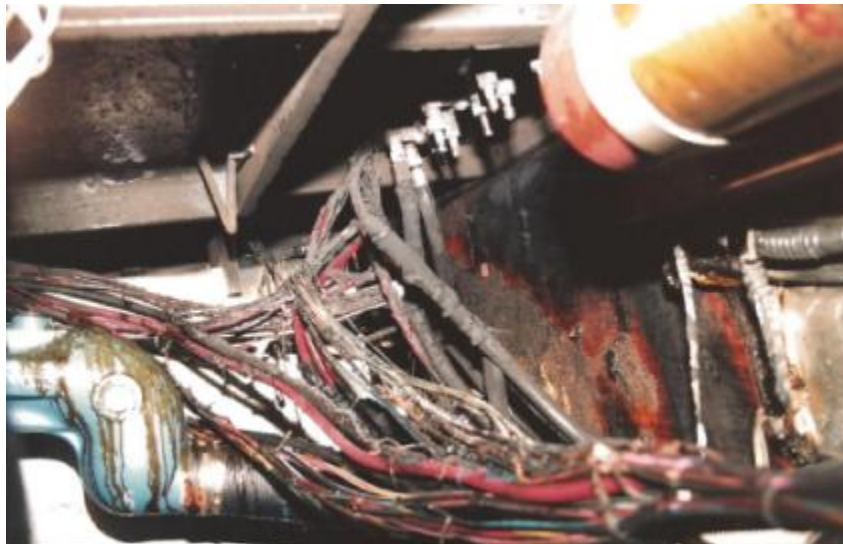
The photograph below shows the wiring in a brand new \$140,000 river cruiser in which a short circuit occurred. The estimate for the repairs to this wiring, which was only damaged in a circle three feet in diameter, was about \$30,000.
