“KEEPING PACE” -#24

AIR TANK RUPTURE:

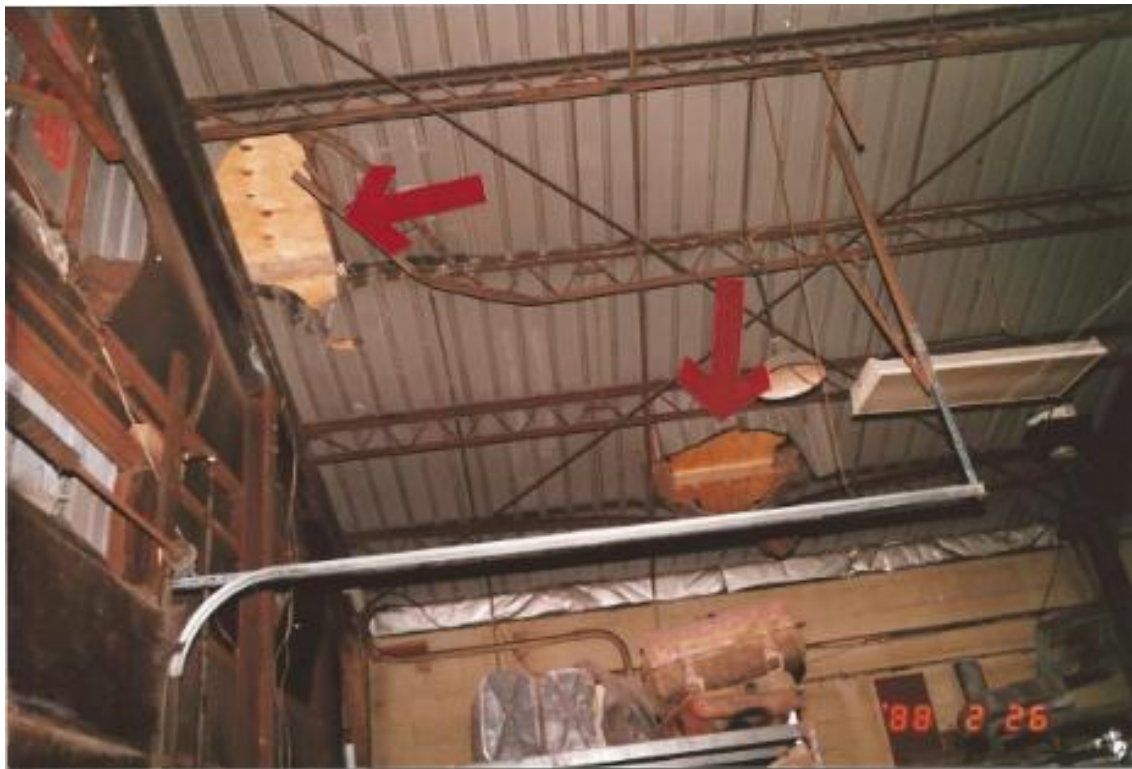
The photograph below shows two holes in the roof of a building in Lorain, Ohio. A six foot tall steel air tank's bottom ruptured and shot the tank upward through the roof. It arched through the air and then back through the roof to land on the concrete floor. This air holding tank for the compressor, much like the one you see in a gasoline service station, had separated from its bottom while there was about 120 p.s.i. inside the tank. Its owner had just walked away from this area to answer a telephone a few feet away. He told me that he does not need to go to a physician to get his heart checked now, because if there were anything wrong with his heart, he would have expired from fright.
