## “KEEPING PACE” - #39

### HOW COULD IT HAPPEN AFTER 12 YEARS?

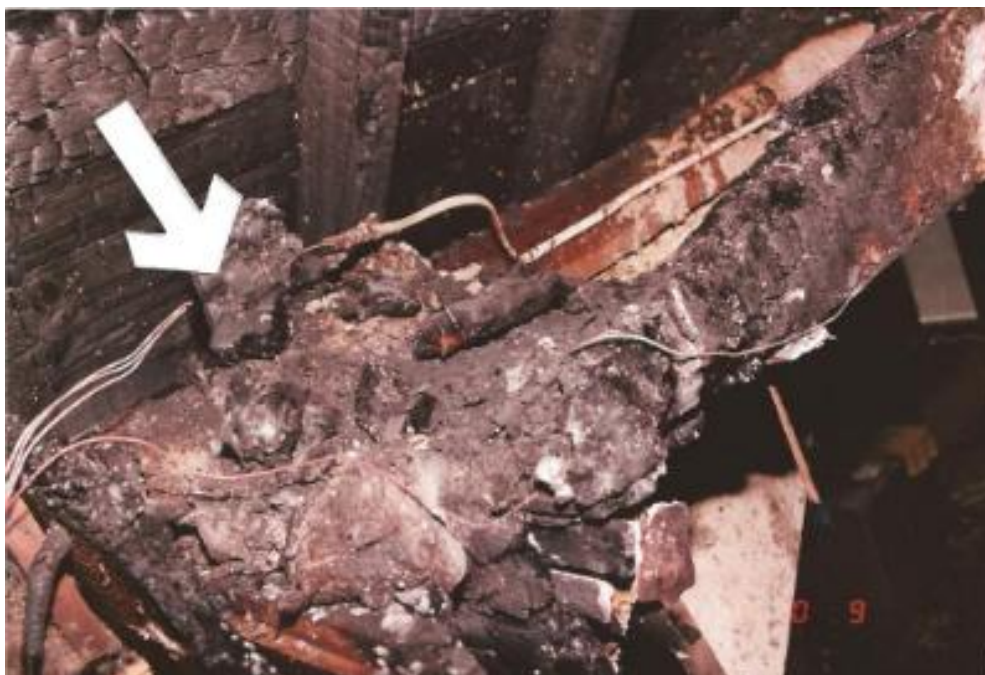
The photograph below shows a romex-type (NM) cable in the attic of a prominent Ohio state senator’s private law office. It short circuited and melted apart 12 years after it was installed, and caused about \$100,000 fire damage. How does a cable short circuit so long after it was installed? I demonstrated some mechanical analogies of this situation earlier in [“Keeping Pace” - #16 and #20](#). Here now is my electrical theory: When the electrical conductor is installed inside the wall of a building or in the dashboard of a vehicle, the installer accidentally cuts it, bends it too sharply, or in some other manner creates a tiny crack or defect in the insulation between two conductors (see the drawing on the next page). Because there is always some humidity in the air inside that small crack, very tiny microcurrents (microamperes) begin to flow through the moisture in the defect. Those microcurrents flow for many years unabated. As the current very gradually increases, it eventually begins creating a carbon path. Finally, so much carbon builds up that a flashover, or arc occurs. Because many (common) American circuit breakers take half a second or more to open, the 6000 watts of power which are dissipated in the arc throw molten copper globules at a temperature of over 5000° F. all around, and a fire begins.

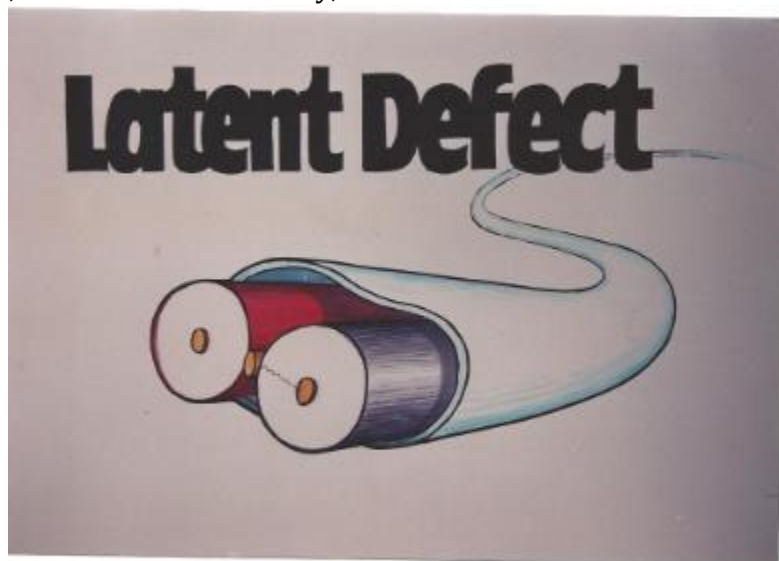
A bus duct then is simply an enclosure around the bus bars to help keep out water and dirt and to keep people from being electrocuted. Because the bus bars are energized, they must be insulated from the outside, and from each other. This is accomplished by wrapping each rectangular bus bar with an insulating medium. Again, if this is not performed properly, a defect can occur in the insulation and cause a later short circuit. The small photograph below shows a bus duct on the top of a Kroger building. It short circuited 12 years after it was installed. Once the arc began in this very high current service, the circuit breaker did not open for a long time. The arcing traveled ten feet along the bus duct, totally destroying it, as shown. Fortunately, no fire ensued.

**Moisture in crack allows microcurrents to flow for many years until a flashover occurs.**

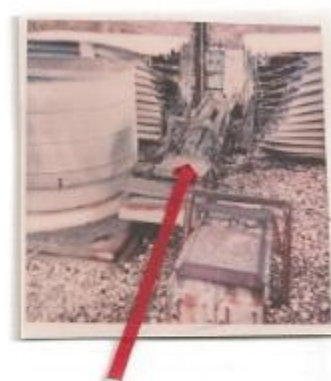
**The arcing traveled 10' along this bussduct.**
