## “KEEPING PACE” - #41

### COLLISION DAMAGE ENERGY:

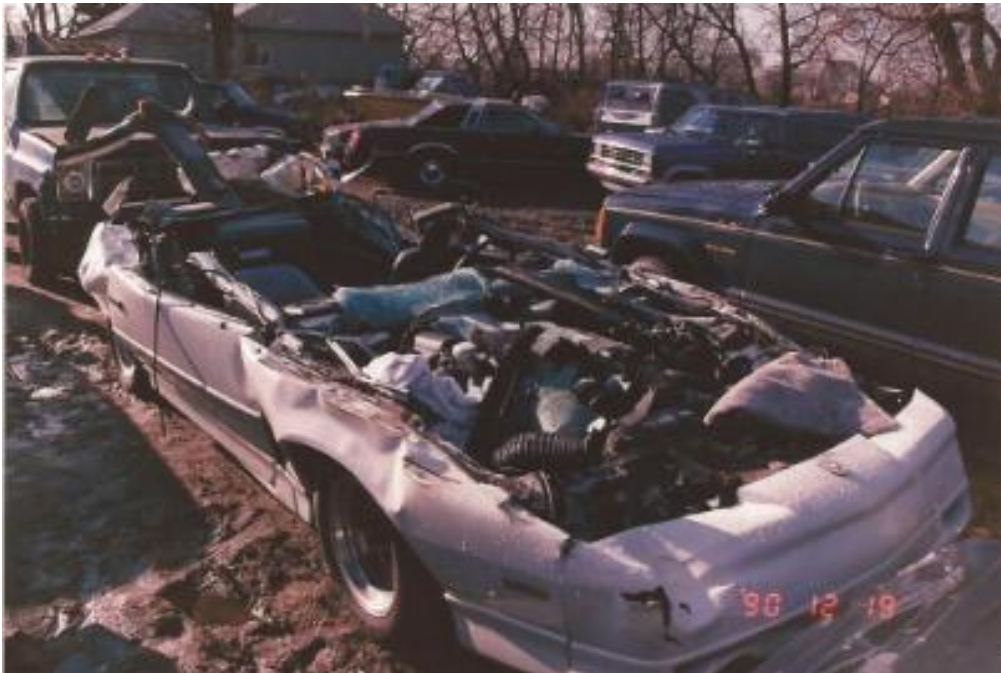
The photograph below shows a 1989 Pontiac Trans Am which struck a large truck broadside at a four-way stop in a residential neighborhood. It may be observed that neither the engine nor the front end of the Trans Am has been pushed backward. Rather, the bottom of the truck peeled off the engine hood and the top of the car. This does not take much energy (speed), because the roof of a car is attached with only a few vertical columns which have a relatively small cross section. Therefore, it does not take as much energy at all to cut through these columns as it does to push the entire front of a car and its engine backward a significant distance. I estimate that the Trans Am was traveling at about 30 mph when it struck the truck.

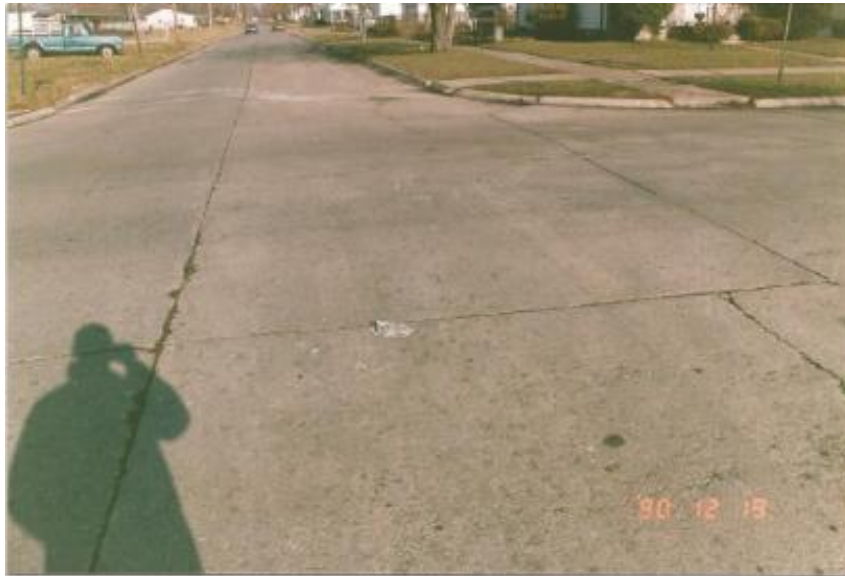
The roadway was wet at the time of the accident, but when I went to the scene five days later, I still found very light skid marks, as shown in the next photograph. The track width and the unusually great tire widths of the Trans Am (see third photograph) matched up completely with the measurements of the skid marks at the scene. So there was no doubt that the Trans Am had left the 118' of skid marks which were found.

Normally tires do not leave skid marks on a wet surface, but these Goodyear Eagles are made of a softer rubber than normal. Only by thoroughly checking the accident scene, instead of assuming there were no skid marks due to the rain, was I able to calculate the true speed of the Trans Am. Using the skidding distance of 118', I calculated the speed of the Trans Am to be about 55 mph at the beginning of its skid, on a residential street which had a 25 mph speed limit.
