## “KEEPING PACE” - #48

### **PYROLYSIS**

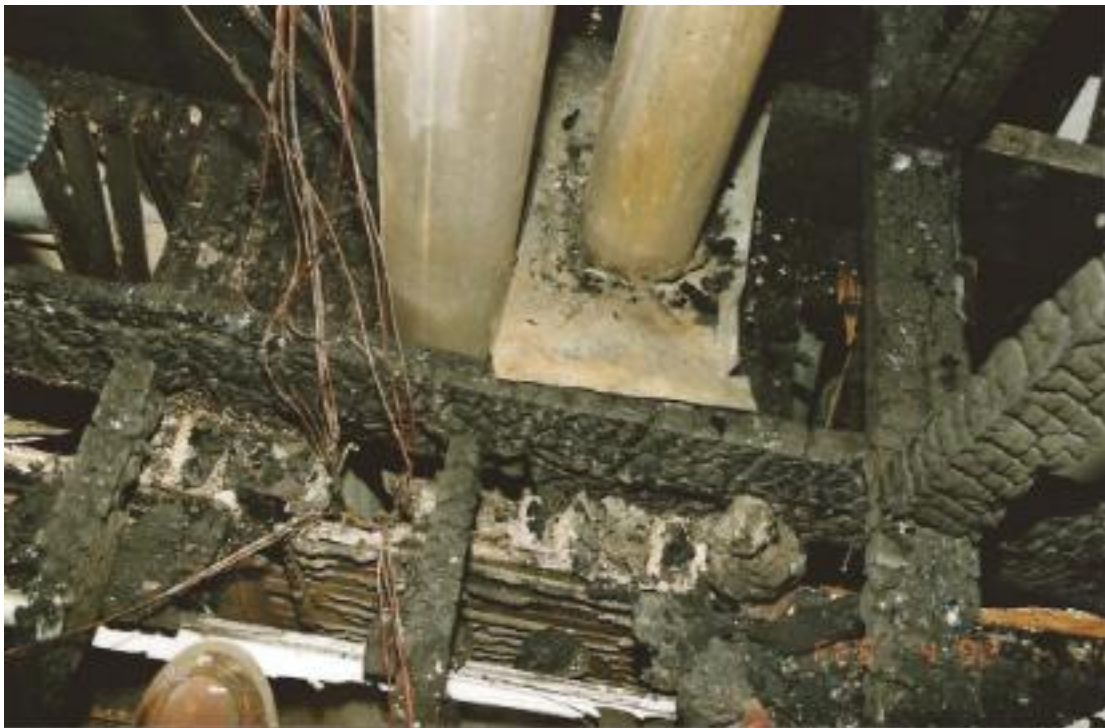
The photograph below shows a furnace flue pipe which had been installed directly against the wood joists in the attic of an apartment building in Cincinnati for 10 years before it set the attic on fire. Over those years, the heat in the flue pipe gradually dried out the adjacent wood and carbonized it, so that its self-ignition temperature was greatly reduced. The normal self-ignition temperature of wood is 400°-450° F.

“Part II is a survey of available information on the ignition of wood exposed to moderately elevated temperatures. Records of actual incidents, laboratory reports on experiments, and published technical literature were reviewed. They indicated authentic instances of the ignition of wooden surfaces exposed for long periods of time to low-pressure steam pipes and similar heat sources; the temperatures of which were in the order of 100 to 120C (212 to 248F).”

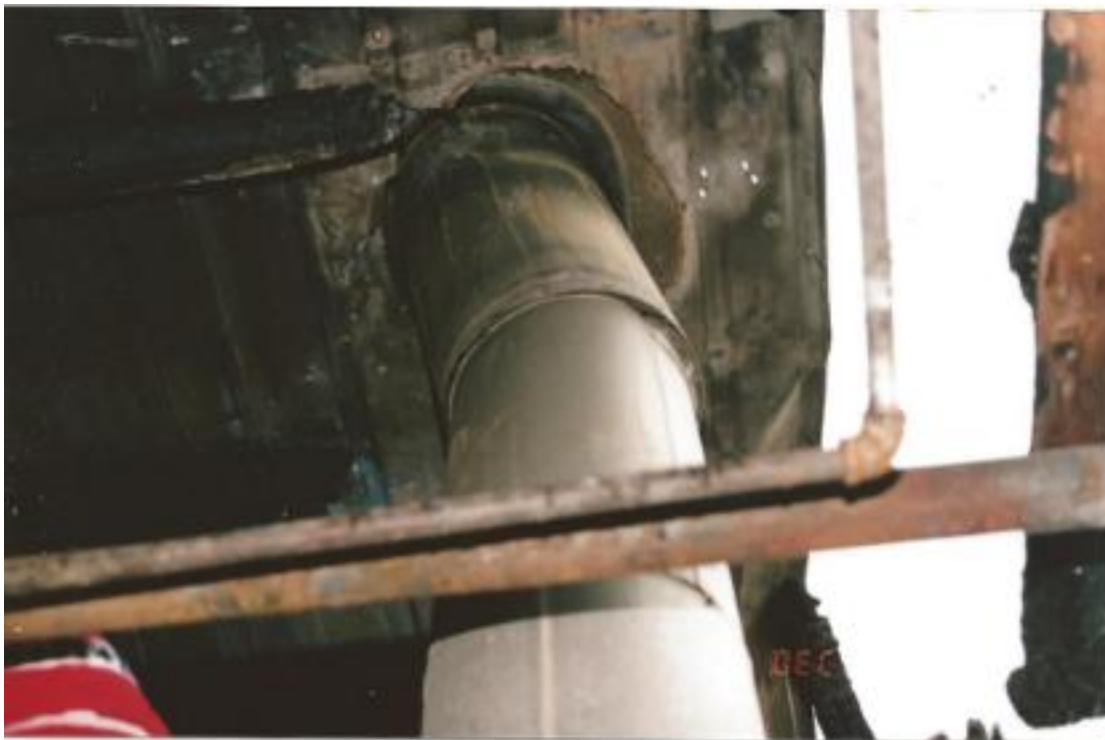
### PREVIOUSLY BURNED WOOD:

Another similar incident occurred in a trucking company building in Cleveland. A small fire had occurred around a boiler's flue pipe just below the roof there from pyrolysis. The trucking company replaced the single wall flue pipe there with a double wall flue pipe, which should have been safer. Unfortunately, they did not also replace the burned wood around the flue. The burned wood had a lower self-ignition temperature than new wood, and a second fire was observed to start around the new flue pipe about two weeks later. This second fire went on to destroy most of the trucking company's building.
