“KEEPING PACE” - #58

LEAVING CHILDREN IN PARKED VEHICLES IS HAZARDOUS:

WHY DIDN'T THE AIR BAG WORK?

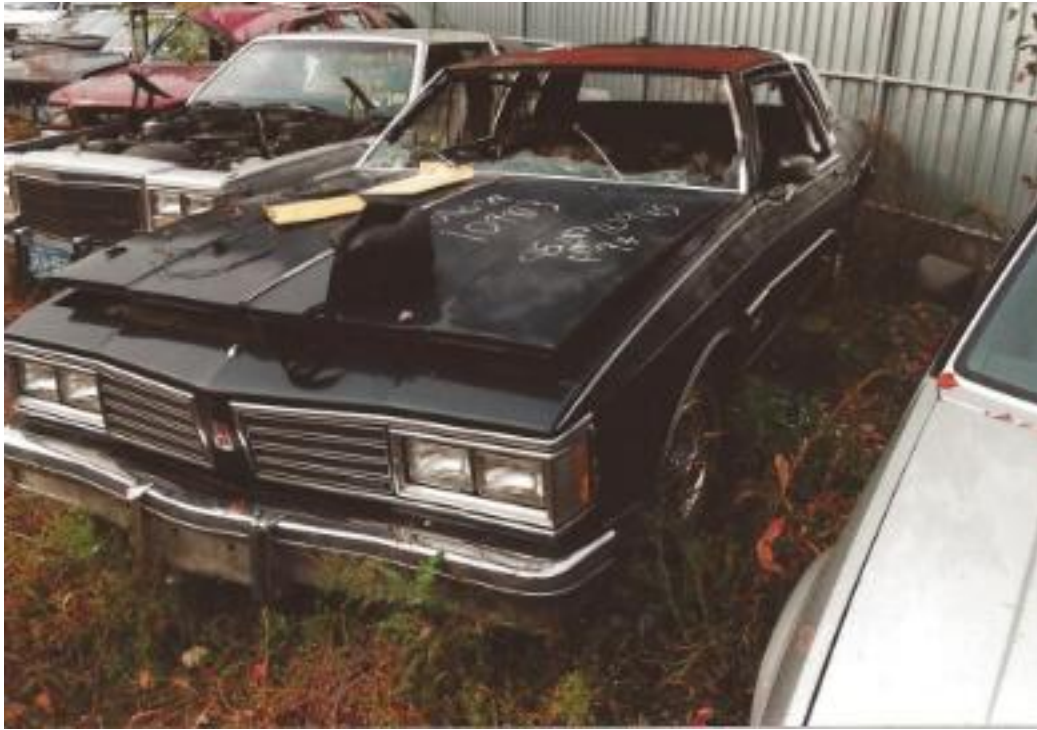
This photograph shows a 1985 Oldsmobile Delta 88 in New Jersey which sustained a short circuit fire in its door lock switch while a nine-month-old child was strapped into a child's seat in the rear of the car. His adult babysitter had parked the Oldsmobile, turned off its ignition, and gone into the house momentarily to get her mother. The short circuit in the door switch locked the doors, so passersby could not open the doors. By the time they were able to break the rear window, the fire was so intense that they could not rescue the child. The child perished.

Most people never think about the fact that some electrical wires in vehicles remain energized, even after the ignition key is turned “off.” Thus, a short circuit fire can occur at any time.

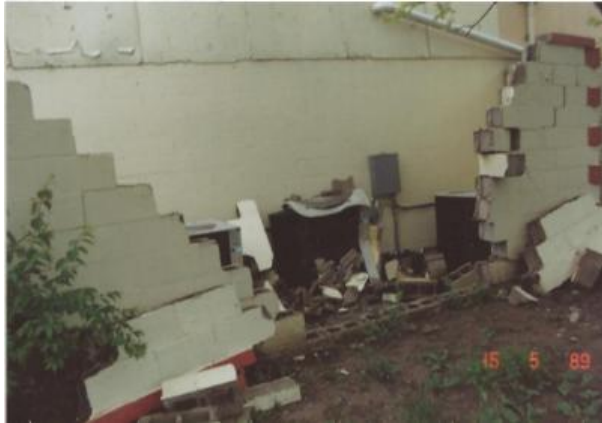
The photograph on the left shows a cinder block wall which the driver of this BMW went through during an unintended acceleration accident. The driver of the BMW parked parallel to the front door of a building, went inside briefly, came back out, strapped on her seat belt, and then accelerated forward about 30 feet into the wall.

Besides wanting to know what was wrong with the accelerator mechanism, the driver also wanted to know why her air bag did not deploy, even though she was not injured. The answer is that the cinder block was soft enough to slow the BMW down more gently than a concrete wall as the block gave way. This resulted in comparatively low g forces. The damage on the front of the BMW indicates a Delta V, or ΔV , of approximately 15 mph.

To avoid nuisance trips, such as when the car goes over rough railroad tracks, most air bag systems require a ΔV of roughly 20 mph before they will deploy. (For a ΔV of 35 mph, see issue #11).

There was also nothing wrong with the BMW's accelerator. This was another case of pedal misapplication.
