## “KEEPING PACE” - #67

### MORE ON FUEL LINES:

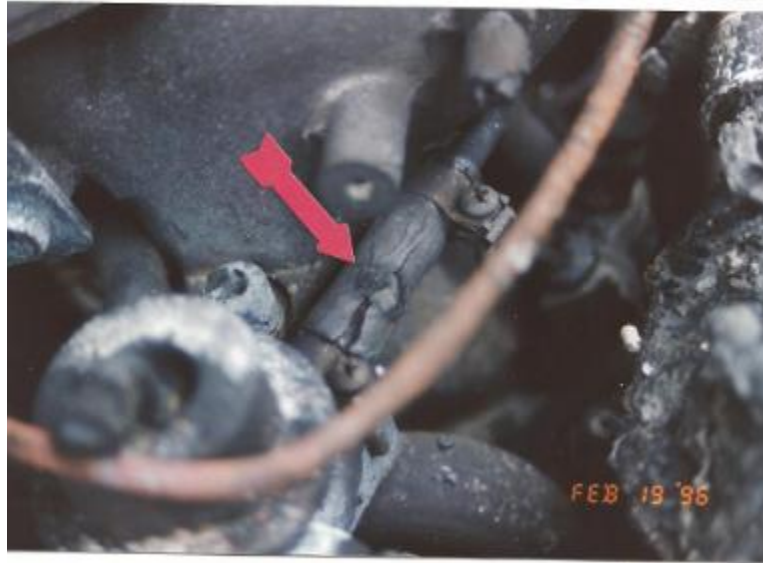
In my last newsletter, I discussed how neoprene rubber-type fuel line hoses are a significant cause of vehicle fires, and how some people tend to doubt this because there is almost never any rubber left to analyze.

A very rare case in which the rubber was not consumed is shown above. The black mark at the center of the rubber hose was left by fire burning back to the liquid gasoline being sprayed from that point.

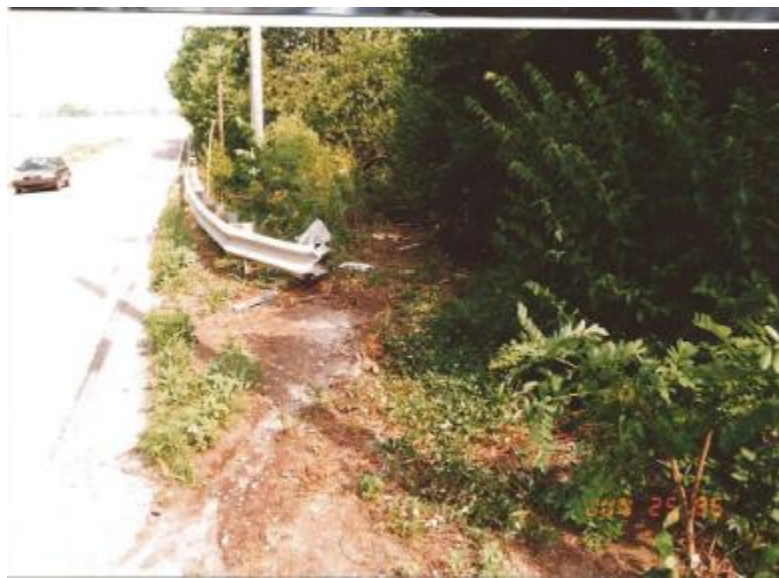
The foregoing photograph shows an accident scene where a policeman’s head struck the windshield, creating the usually fracture pattern in the glass, even though his airbag had deployed. The airbag deployed as his police car went through the guardrail shown. But when the police car hit a tree 40’ farther on, the airbag had already deflated.

Airbags are designed to deflate very quickly, in about 0.045 second, so that the driver can keep on driving if he needs to. Fortunately, this policeman was not injured, even though he was violating state law by not having his seat and shoulder belt attached at the time of the accident.

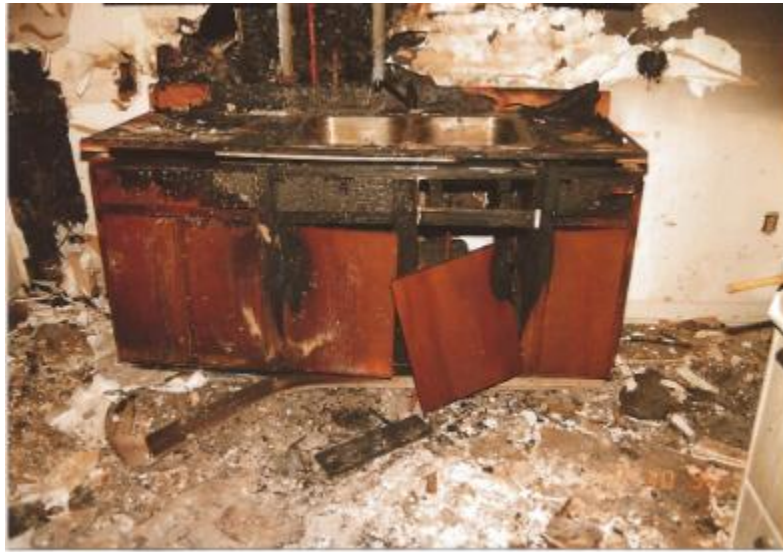
At 11:30 a.m., the plumbers used a torch to sweat copper water pipes inside the kitchen cabinets shown. They and other workmen walked by at about 5:30 p.m., but because the cabinet doors were closed, no one noticed a fire smoldering inside. At 11:30 p.m., the fire broke out and damaged four apartments.
