## “KEEPING PACE” - #9

### SUSPICIOUS BURN PATTERN:

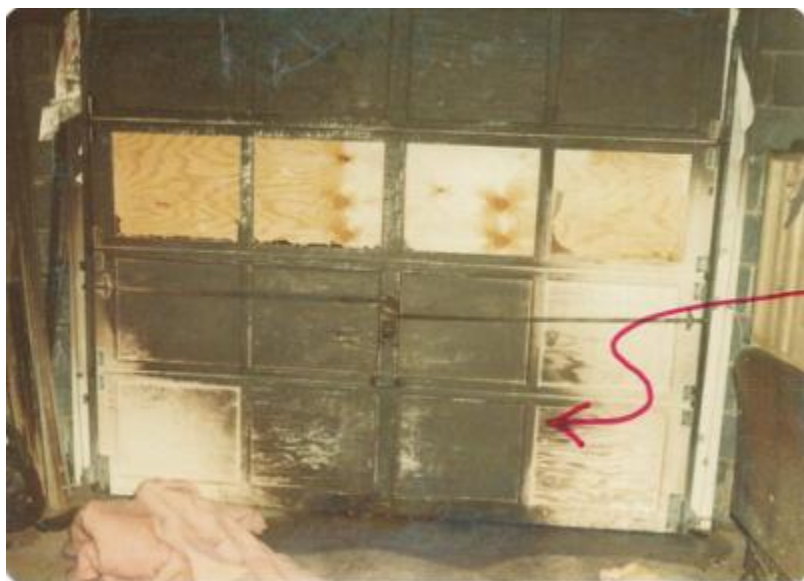
The above photograph shows the interior of a basement garage door. A fire occurred in this basement garage in Huntington, West Virginia, three and one-half hours after a lady pulled her automobile into this garage. This was definitely a fuel (gasoline) fire and the fire looked suspicious. However, I traveled to where the automobile was being stored and poured five gallons of gasoline into its tank to check for any leaks. To my surprise, a one-quarter inch stream of gasoline emanated from the hole in the bottom of the fuel tank.

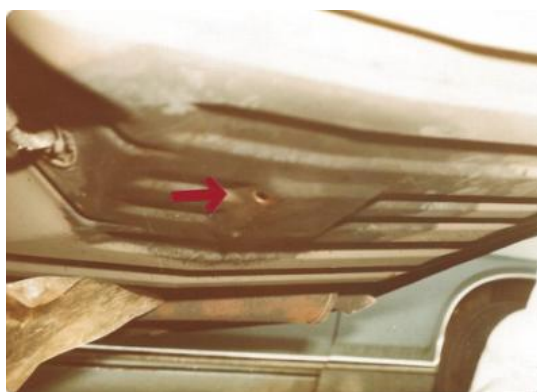
All we could conclude was that a stone had kicked up on the road and pierced the fuel tank. That opinion was vindicated a few years later when another car pulled into the parking lot of my office building trailing a similar stream of gasoline from a fuel tank puncture. No fire occurred in that instance, because I called the fire department to flush away the fuel.
