“KEEPING PACE” - #47

KEROSENE HEATER FIRES:

FIRE DEFENSE CASE:

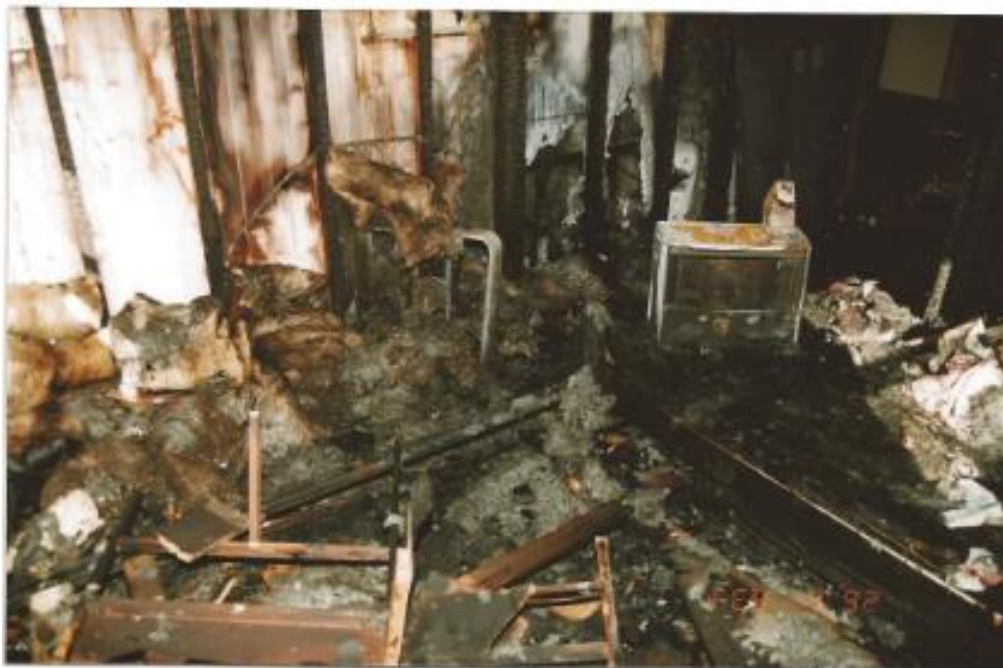
The photograph below shows a rectangular shaped kerosene heater which has a gravity feed fuel system. A fire occurred sometime after the occupant of this bedroom went to sleep. It may be observed that there are burn patterns on the wall adjacent to the kerosene heater demonstrating that the kerosene heater is at the area of fire origin. From past experience, I was reasonably sure that someone had poured gasoline into this kerosene heater's removable fuel tank by mistake.

I took the kerosene heater for chemical analysis, in which a gas chromatograph was used to test for gasoline in the carpeting attached underneath the heater. None could be detected. Then the chemist tested for gasoline in the heater's cloth burner wick. None was present. Finally, the chemist tested for gasoline fumes in the (empty) fuel tank, and this test was positive for gasoline. This proved beyond any doubt that gasoline had accidentally been poured on top of the kerosene in the fuel tank. Since gasoline is lighter than kerosene, the gasoline did not enter the burner until the kerosene was used up. This can take from one to four hours or more, in my experience.

In the garage of the home, I found the gasoline fuel containers sitting right next to the kerosene containers. The accident pouring of gasoline into kerosene heaters has caused a number of fires which I have investigated.

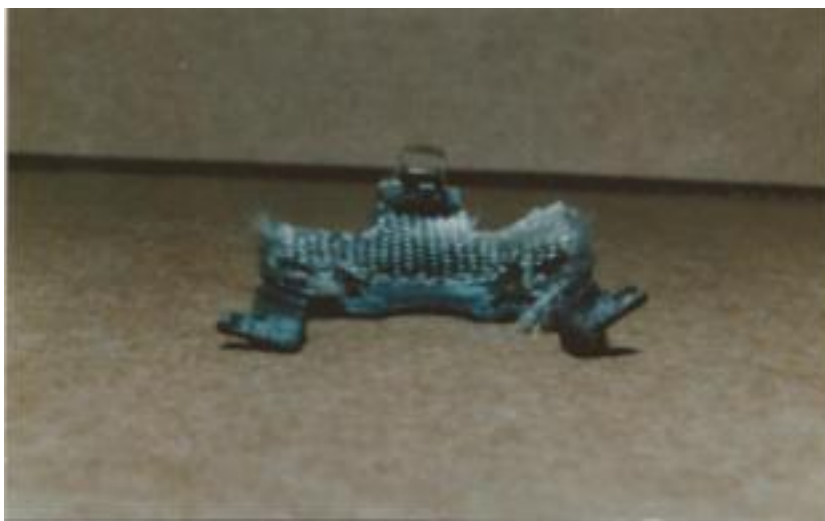
This was a \$400,000 fire defense case which my clients won at trial in Indianapolis. Another expert claimed that a small part, shown below after it had been through an intense fire, had been installed improperly in a thermostat during manufacture, and consequently, the thermostat had caused the fire. The expert stated he could tell this because the ends of this small thermostat part were “warped.”

To test this assertion, I put four new thermostats of the same model into a campfire and demonstrated on a video that these pieces warped as a result of the heat from the fire, when the plastic resin was consumed away from the fiberglass cloth. The real cause of the fire was that a thermostat with a 180° F. maximum temperature setting was replaced on the day of the fire with one having a 595° F. maximum setting. In addition, the new thermostat rotated in the opposite direction from the old one. The owner had accidentally set it to “HIGH” rather than “OFF.” Finally, no high temperature limit thermostat was installed when the company converted this water bath to an oil bath on the same day this fire occurred.
