“KEEPING PACE” - #49

BLOWBACK

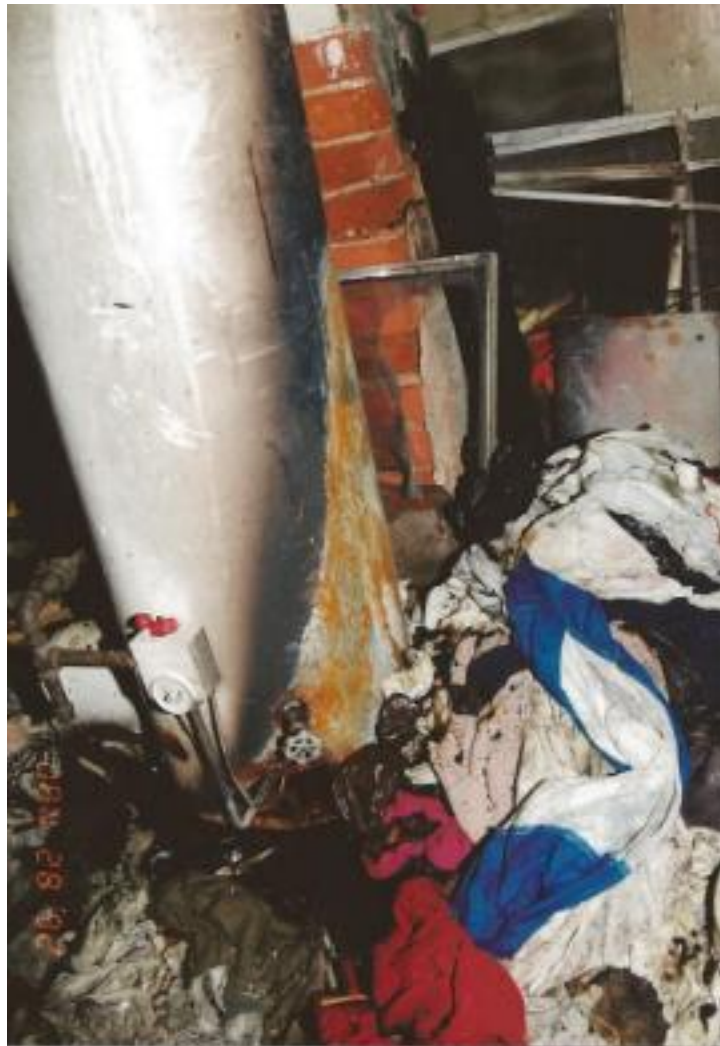
The photograph below shows clothing placed too close to the burner area of a gas-fired hot water heater. A fire began there and then burned upward inside the walls to vent through the third level floor. Until I examined the insides of these walls, this fire appeared as if it had three areas of origin. A “blowback” occurs once in awhile when there is a little more gas in the appliance than normal when the gas ignites. It can sound like a “kawoomp.” The extra burning gas is forced outside the appliance, momentarily, and it can ignite nearby combustibles placed too close to the appliance.

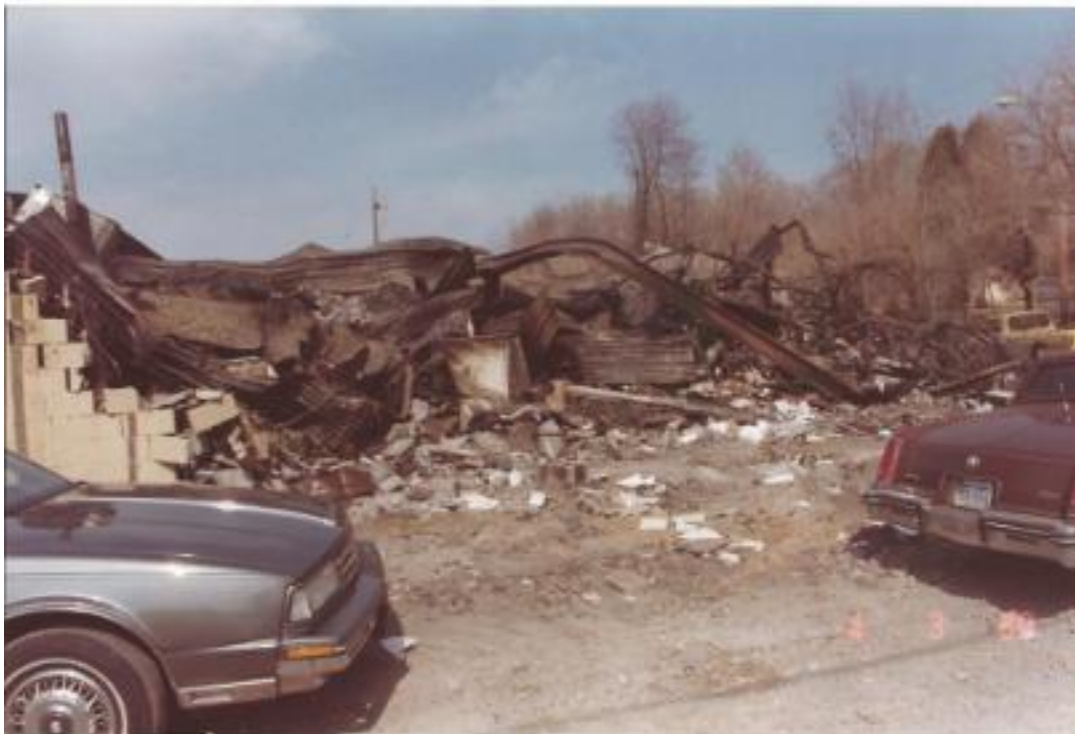
The next photograph shows a building totaled by a blowback fire, which obviously originated at the furnace area. The fire department saw flames shooting through the roof above the furnace when they arrived. They also found a protected spot on the carpeting near the front of the furnace, which proved that a cardboard box of papers had been placed on the floor there, too close to the furnace. The workers confirmed that there was a metal shelf full of papers located there with one end 28 inches from the furnace.
