“KEEPING PACE” - #55

CRANE FAILURE:

CRANE TRIAL:

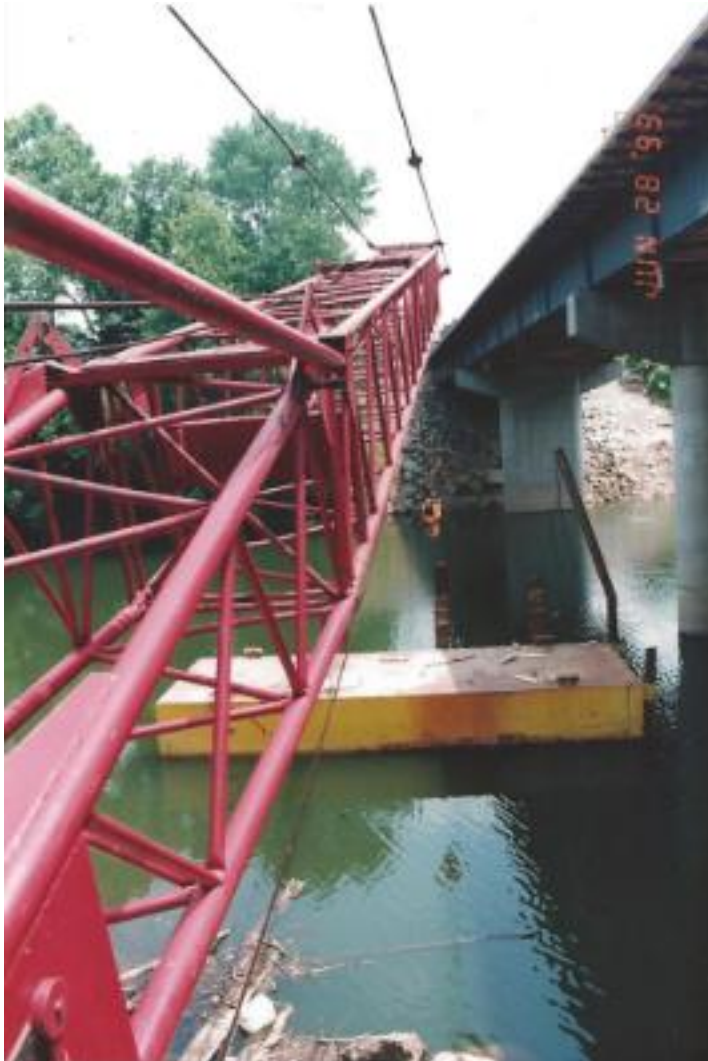
The owner admitted that he had been trying to remove this steel piling with his boom at a 10° angle to horizontal. That placed extreme overloads on his crane and immediately caused the boom supports to fail via severe bending.

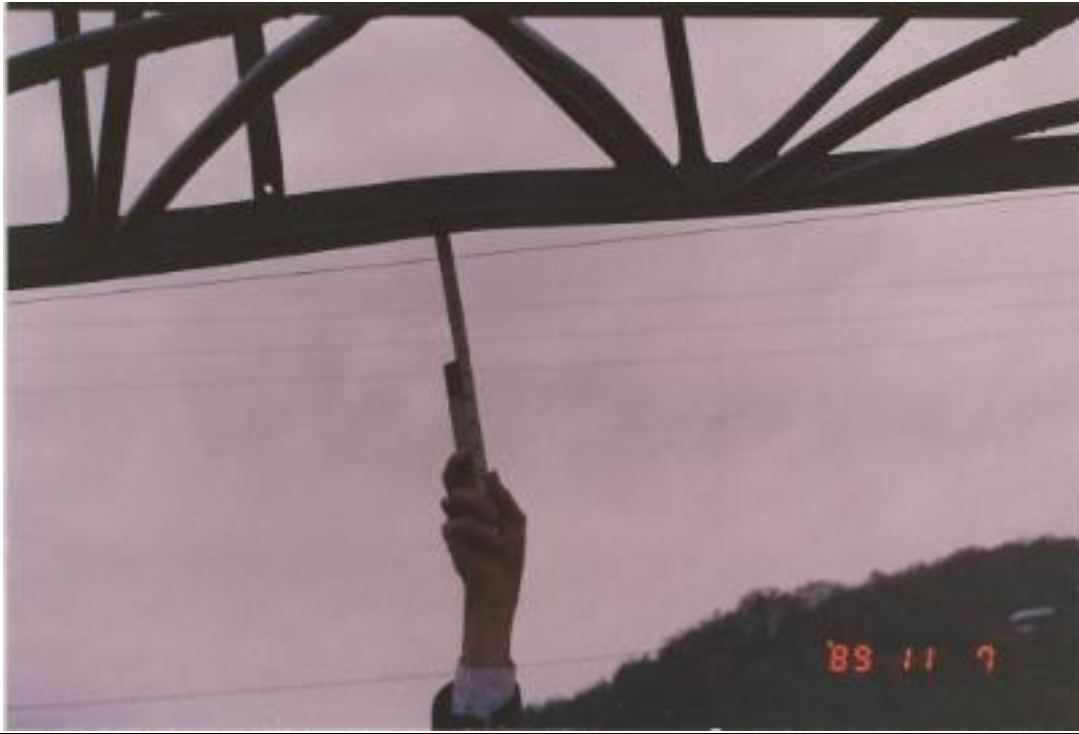
This photograph was taken to show that the boom of a crane had been overloaded at some point in time. The boom was warped by 1½ inches, as demonstrated by the taut string and the ruler. The new owner of the crane claimed that the trucking company which had transported the crane to his office had caused the overload.

By comparing the damage to the boom and the way the crane had been attached to the truck, I proved that the transport of the crane did not cause the overload. In a telephone conversation, the new owner of the crane admitted to me that the boom was “a little bent” when he inspected the crane prior to purchasing it. However, he insisted that the case go to trial, and so a one day trial took place in Prestonsburg, Kentucky.
