“KEEPING PACE” - #59

BURNER CONTROL SHAFTS:

FLUORESCENT BALLAST BANK FIRE:

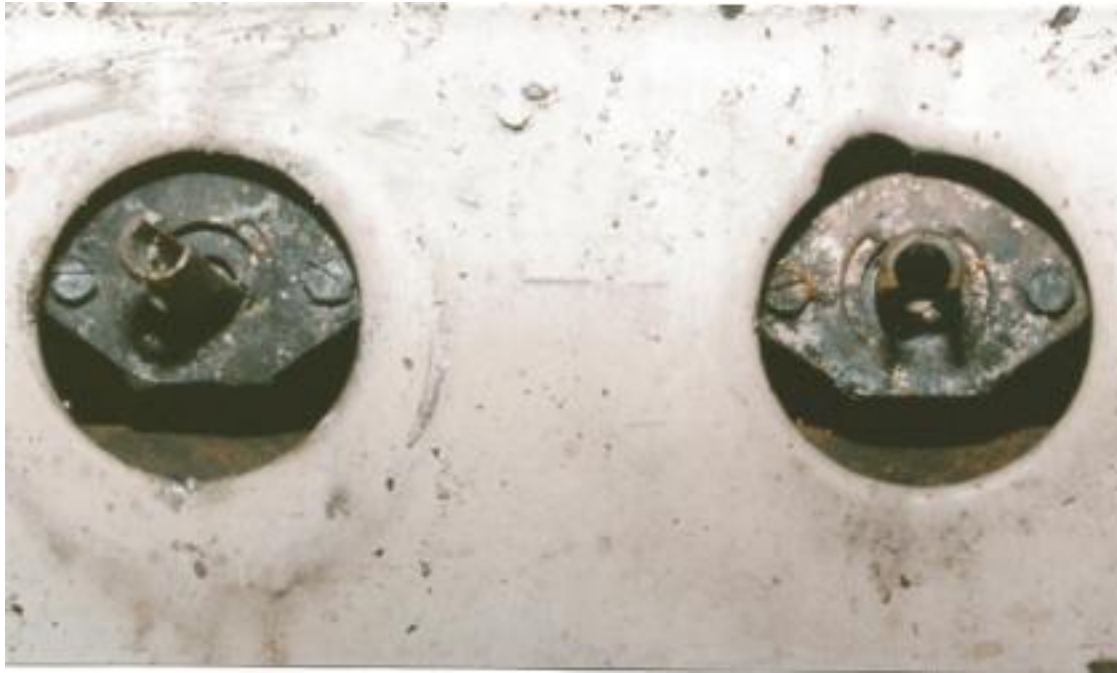
We have talked before about one telltale sign of a careless cooking fire, which is the pattern left on the bottom of a skillet or pan by the burner on the kitchen range (K.P. #30 and #55). Another telltale sign is to find the shaft for one burner knob rotated with respect to the other three shafts. The photograph above shows two gas range burner controls after the plastic knobs have been consumed by the fire. These burner controls are always manufactured with the notch or slot in the end of the metal shaft at a certain orientation, which is usually either down for a notch or vertical for a slot. The plastic knobs then slip onto the ends of these shafts, and the knobs rotate the shafts to control the burners.

In the photograph, the notch in the left shaft is in the 2 o'clock position. The notch in the other shaft, as well as the other two shafts on the range (not shown), are all at the 6 o'clock position. Because the subject shaft was mechanically frozen by the ensuing fire damage, there is no doubt that this gas burner was on “high” at the time the fire occurred.

The lady tenant admits that she left hamburgers and grease on top of this range, and that her two-year old son has turned these controls “on” at times previous to the fire. However, before I demonstrated this shaft position to her, she blamed the fire on numerous electrical problems she had been experiencing in her apartment.

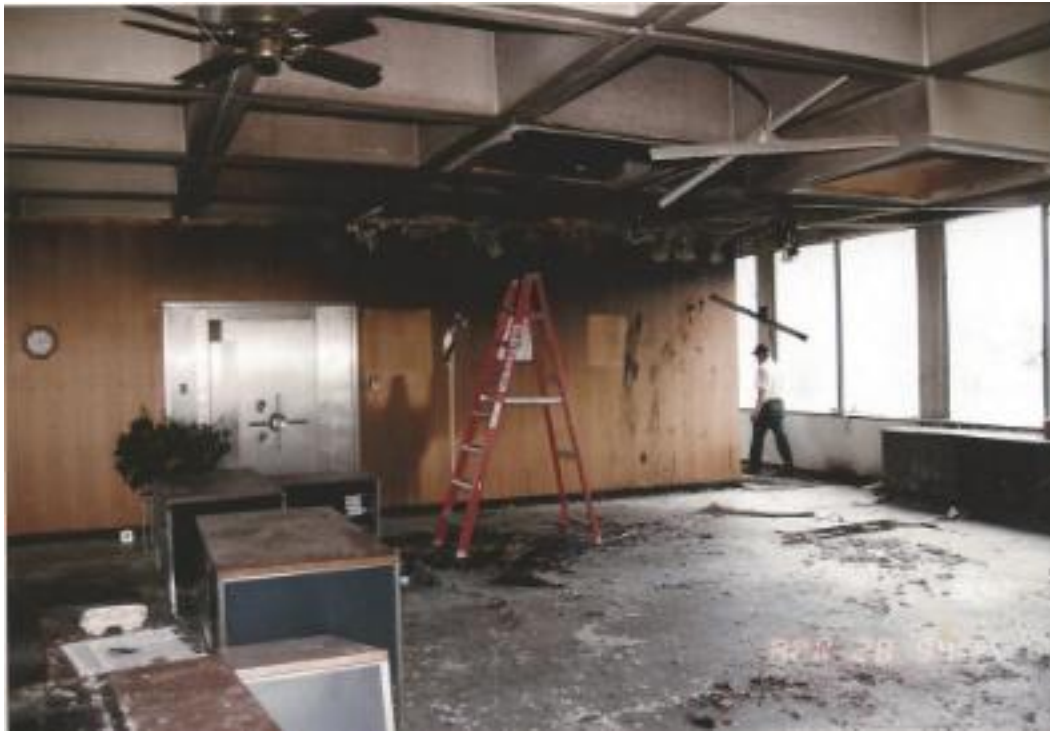
The photograph shows a ceiling which burned during a fire caused by an overheated fluorescent lamp ballast. This occurred at 3:00 a.m. in a bank near Lexington, Kentucky. All the electrical wiring in the ceiling was enclosed by conduit, and I could find no short circuit arcing melt anywhere. In 1977, the National Electrical Code™ began requiring a “thermal protector” to be installed in every ballast to turn it “off” if it ever overheated. However, this subject ballast was installed in 1974, and so it had no such protector.

Fluorescent ballast fires always were very rare occurrences. With thermal protectors, they have become virtually nonexistent.
