“KEEPING PACE” - #87

BRIDGESTONE™ TIRE TREAD:

FLAT TIRE NOT CAUSE:

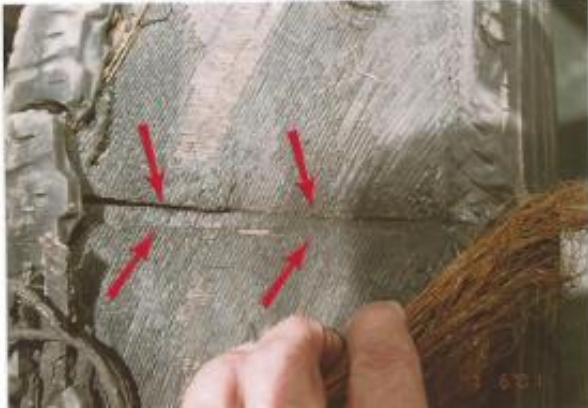
The above photographs show a Bridgestone™ automobile tire which blew out while the driver was traveling at 65 mph on an interstate highway. Fortunately, no injuries occurred. The insured driver blamed the tread for coming off the tire to cause the accident. However, the photograph on the left shows two parallel cuts across the grain of the cords.

Thus, I determined that this piece of metal was kicked up by the left front tire and thrown into the left rear tire, where it cut the tread and cords of the tire to cause the blowout. The accident was not caused by a tire defect.

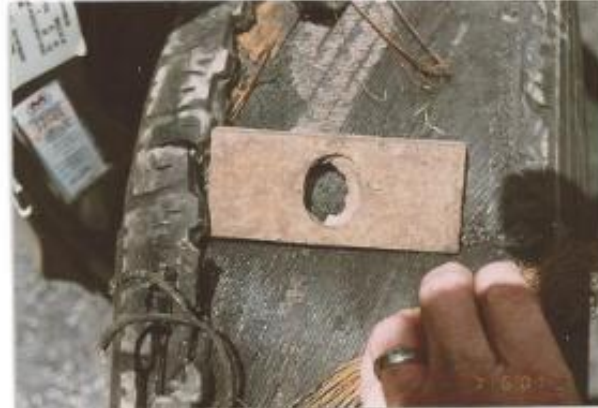
The photograph on the right shows a 3/8" thick piece of metal I found along the edge of the road by searching the roadway at the accident location. The thickness and length of this metal piece matched the width and length of the parallel cuts in the cords of the tire.

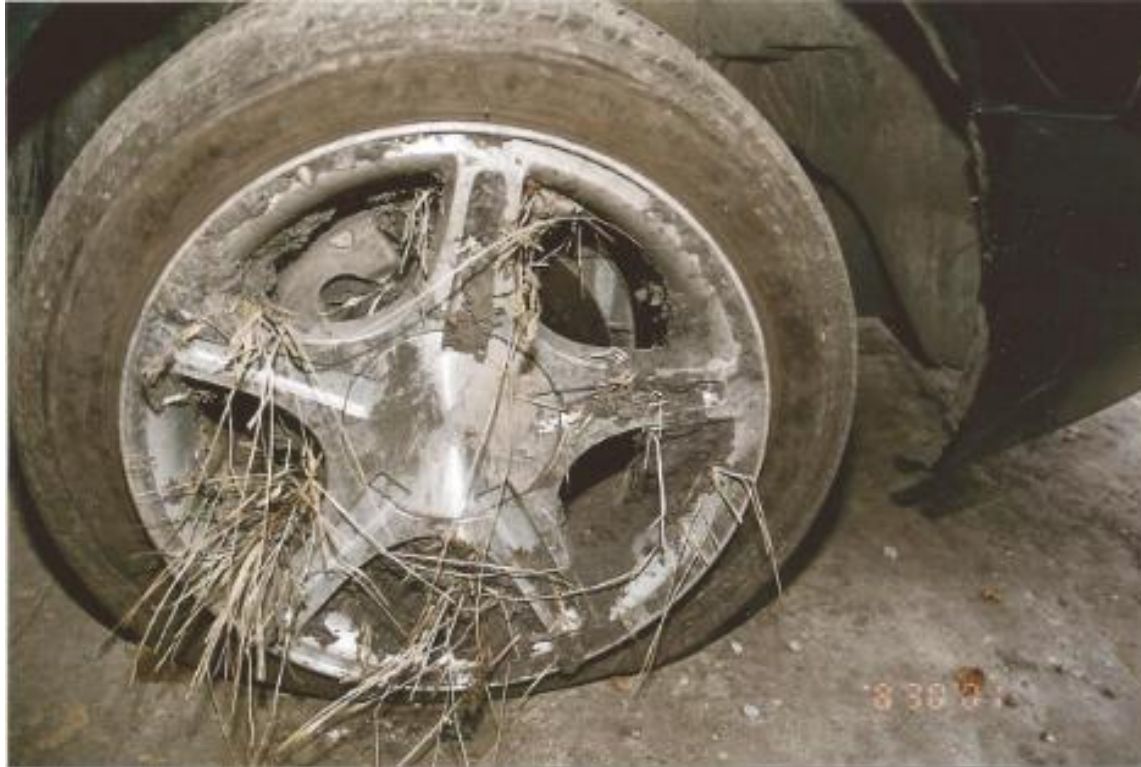
The photograph shows a flat tire on a vehicle near Pikeville, Kentucky. The driver claimed that this tire blew out to cause an accident as she made a right turn and hit a bridge. But I could see no holes or cuts in this tire. Also, when I repositioned this tire on its rim and pumped it up, it held air. Thus, I concluded that the tire had simply been knocked off its rim during the ensuing accident.

I have investigated accidents in which the tire was deflated like this during the ensuing accident about ten times in my career. In each case, I proved there was nothing wrong with the tire, because once it was placed back on a rim, it held air.
