“KEEPING PACE” - #33

220 FOOT RADIO TOWER COLLAPSE:

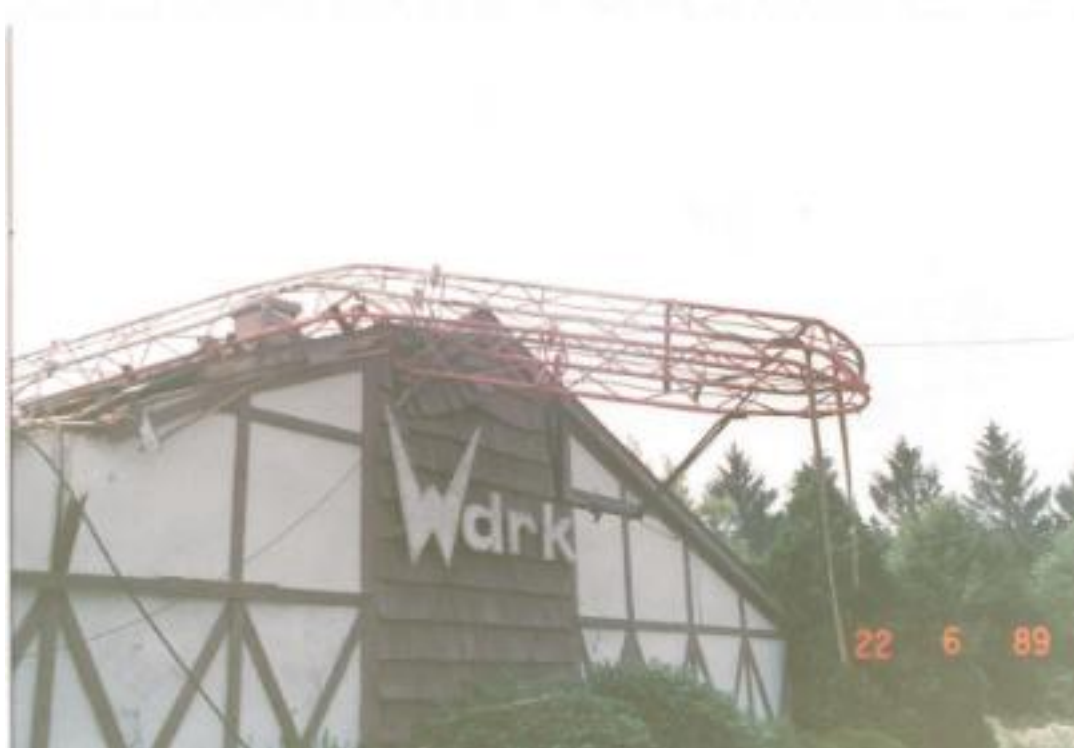
The WDRK radio station in Greenville, Ohio had ceased operation and had been sold. A buyer decided to move the 220 foot radio tower, so to take it down, he rented a crane with an operator. They connected the hook to the tower about half way up, and then disconnected all the guy cables. Then they attempted to lay this very narrow tower down on its side. Then the tower had reached about a 45° angle, it suddenly bent double at the hook location. As the top half of the tower swung downward, it struck the boom of the crane, breaking it in three places. Then the folded tower fell on the roof of the radio station, as shown. The tethers for the crane hook may be observed hanging from the folded portion of the tower. This confirms that it folded at the hook location.

Narrow radio towers such as this are designed for strength in the vertical direction only. They are very weak in the horizontal direction, and so they rely for horizontal strength upon the numerous steel guy cables attached between various points on the tower and the ground. The proper way to dismantle this tower would have been to unhook only one set of guy cables at a time, starting from the top, and removing only one section of the tower at a time.

Because these towers rely on the guy cables for so much of their horizontal strength, it is a wonder to us that the tower did not immediately fall as soon as all the guy cables were loosened. If it had fallen without bending in half, it would have come down across high voltage power lines and a city street busy with traffic. Fortunately, in this case, no one was injured.
