“KEEPING PACE” - #38

ABSOLUTE TOTALS:

30 AMPERE FUSES:

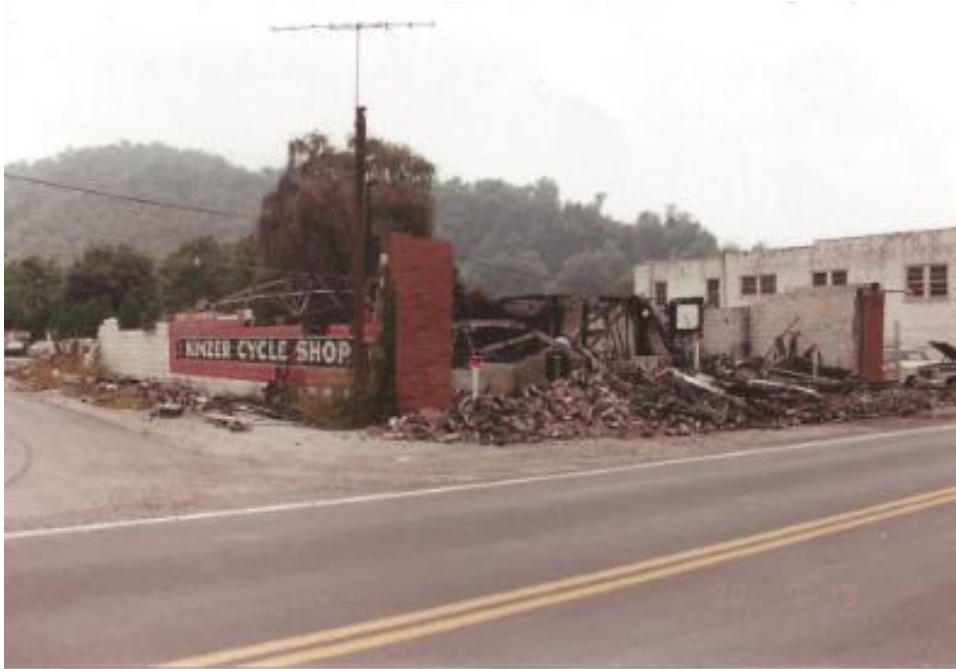
The photograph above shows the paint still remaining on the outside wall of a warehouse in Allen, Kentucky, after the interior was totaled by fire. Surprisingly enough, this concrete block outside wall was a very good insulator against the 2000°F plus temperatures inside. The photograph on the next page shows the interior of this same warehouse. It may be observed that the interior combustible materials have been absolutely, totally consumed. For sixteen years I have termed such fires “absolute totals.” Some people refer to these as “ashes and nails.” They are not infrequent, especially in areas where it takes the fire department a long time to respond. In such fires, only metallic and ceramic materials remain after the fire, with an occasional piece of wood lying here and there among the ashes. Thus, there are no significant burn patterns. Without any burn patterns, it is almost always impossible to determine the general area of origin of the fire, let alone the point of origin, (unless there was an eye witness to it or a security camera). Moreover, all the inner parts of the equipment inside the building are also always consumed, so no testing or analysis of any equipment is possible. More importantly, anywhere one looks in an absolute total fire, one may find melted copper on the wiring. With the wiring being so greatly melted by the heat of the fire, and with no significant burn patterns, it is generally impossible to confirm or rule out a short circuit as the cause.

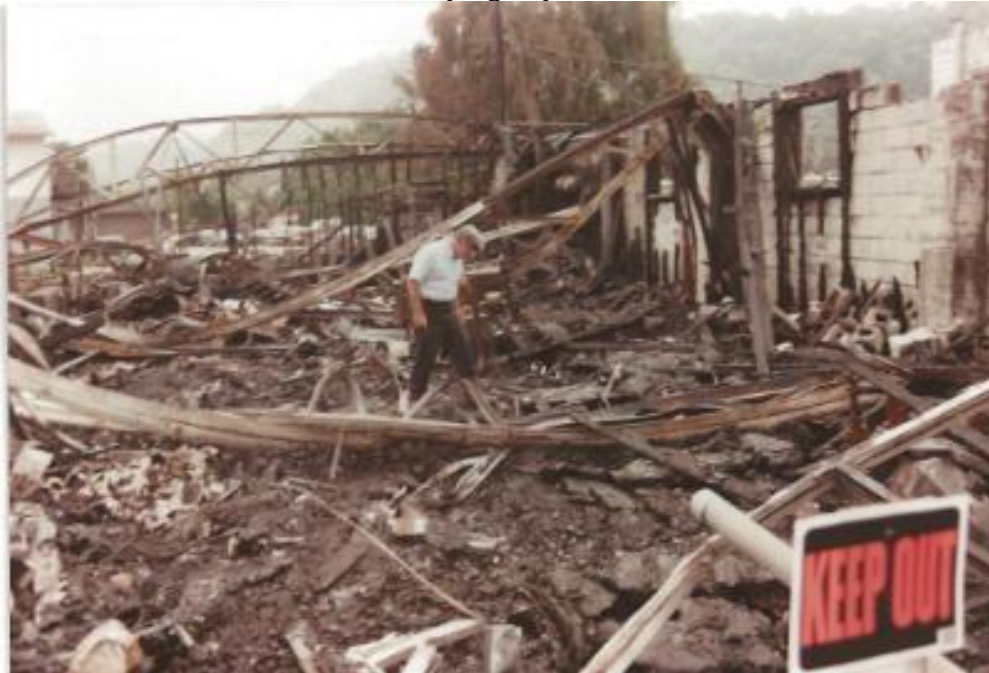
In this same fire, the owner was about \$100,000 underinsured. He had left the warehouse a few minutes prior to his employee discovering the fire burning in the second level and ceiling area. The only source of heating power in that area was electrical, so because of the eyewitness account I concluded that this was probably a short circuit fire (location unknown). More evidence of this was the 30 ampere fuses I found in the fuse panel. Short circuit arcing energy is proportional to the time duration of the arc, or in other words, how long it takes the fuse or circuit breaker to open (pop). Below are the opening or “popping” times which I have measured for fuses at the typical short circuit currents of 200 and 250 amperes:

At 200 amperes, a 30 ampere fuse allows 15 times more energy into the arc than a 15 ampere fuse does. This is really why 30 ampere fuses are more dangerous, and should not be used in place of 15 or 20 ampere fuses.
