“KEEPING PACE” - #56

TRANSMISSION FLUID FIRES:

DEAD BATTERY CAUSES VEHICLE TO ROLL OFF CLIFF:

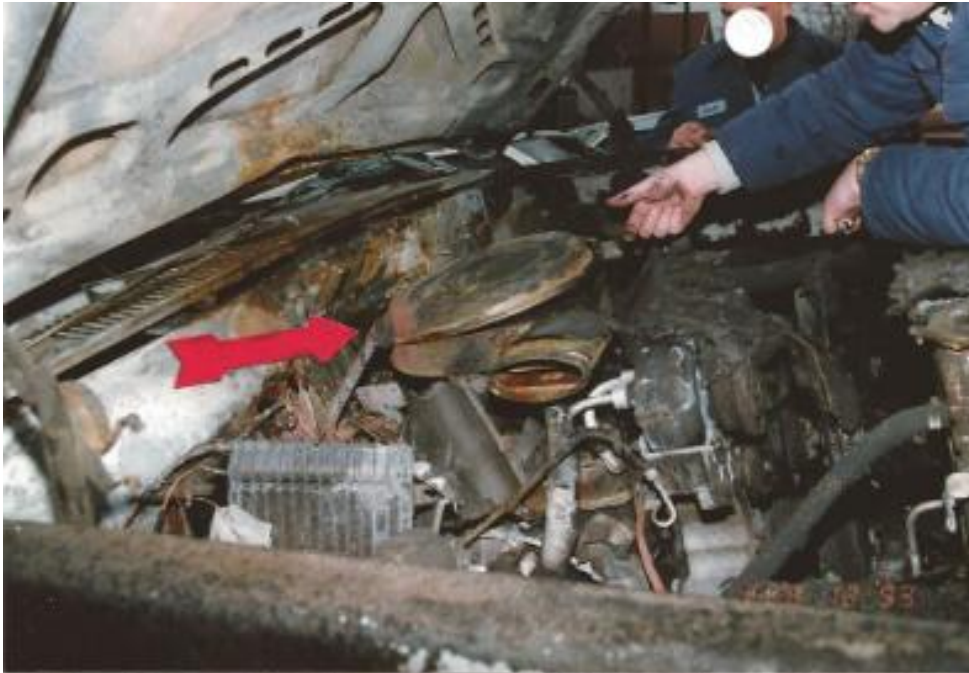
The arrow points to the transmission fluid dipstick tube. A fire originated around this tube after transmission fluid was ejected from it and landed on the hot manifold, because the transmission was being overworked. The transmission fluid also dislodged the dipstick.

This was a four-wheel-drive vehicle pulling a 19 foot boat up a long grade. After there were a number of such fires, manufacturers began putting a clamp, or mechanical lock, on the dipstick to lock it in place. That has greatly reduced the problem, but a few such fires still occur.

Usually, the fact that the vehicle was towing a load at the time of the fire is the first clue, along with the dipstick being dislodged. But we have also seen such fires in motor homes, where just the weight of the load was enough to overwork the transmission under certain driver actions.

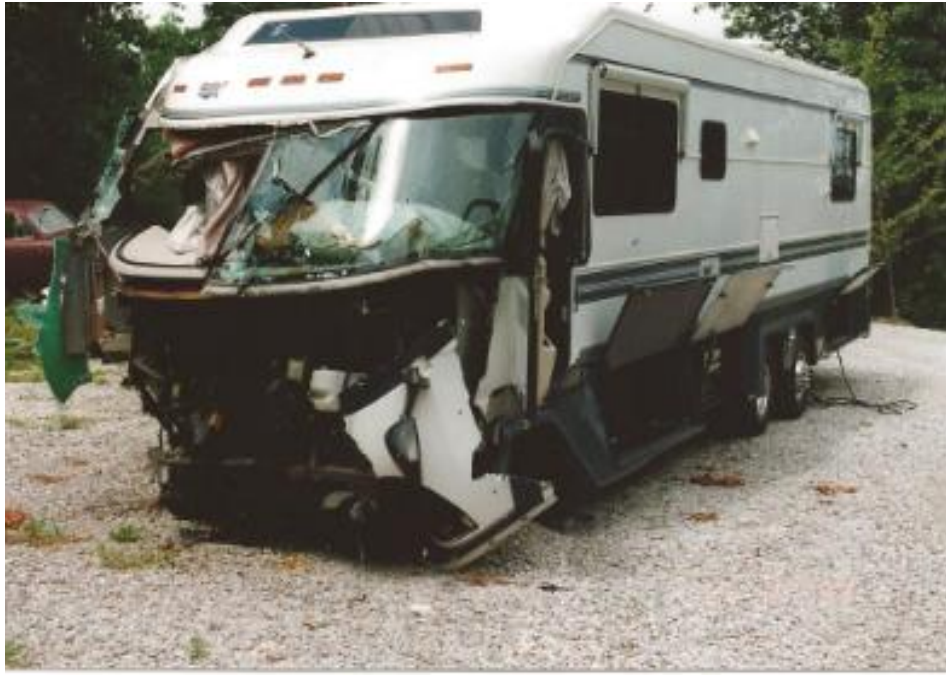
The motor home shown above has automatic levelers, powered by the vehicle's battery. After the motor home is parked, electronically controlled hydraulic levelers raise the motor home on four jacks, and afterward, continually readjust the motor home to keep it level. At the time of this accident, the motor home was parked in the owner's driveway, pointing toward a steep embankment.

The battery charger was not functioning, so over a few days' time the batteries became drained, and the electronic controls for the hydraulic leveling system became erratic. This lowered the jacks, which in turn lowered the motor home onto the driveway.

The owner admitted to leaving the transmission in "neutral." We believe he also left the parking brake "off" and so the vehicle rolled over the embankment. The scary thing is that the owner's children stayed overnight in the motor home the day before this accident, and they played in this motor home on the day of the accident.
