“KEEPING PACE” - #68

HEAVEN HILL DISTILLERY FIRE:

DELAYED IGNITION PROVED IN KEROSENE HEATER:

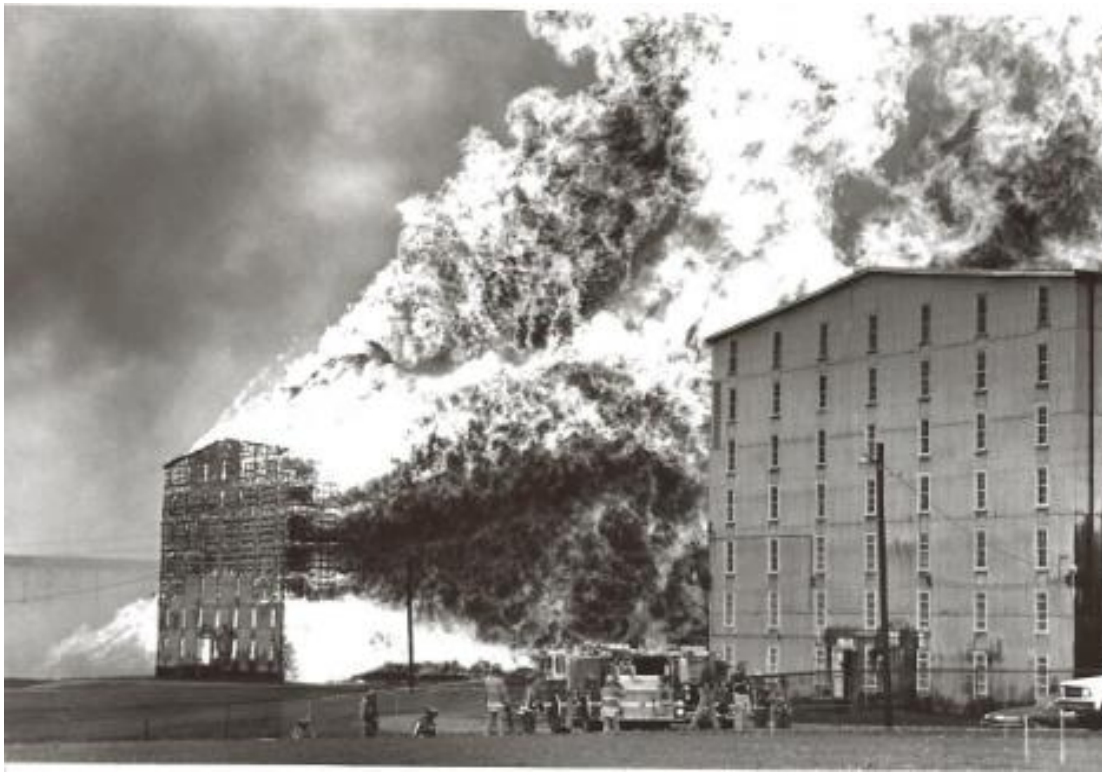
The fireball in this photograph becomes even more impressive when one is told that the two buildings are spaced 250 feet apart. Reporter Rebecca Ray of the “Bardstown Kentucky Standard” newspaper took this photo, which is reprinted here with permission.

Both of these buildings were then destroyed during the fire along with five others like them. Although the firemen lost \$18,000 worth of equipment fighting this fire, fortunately none of them was hurt.

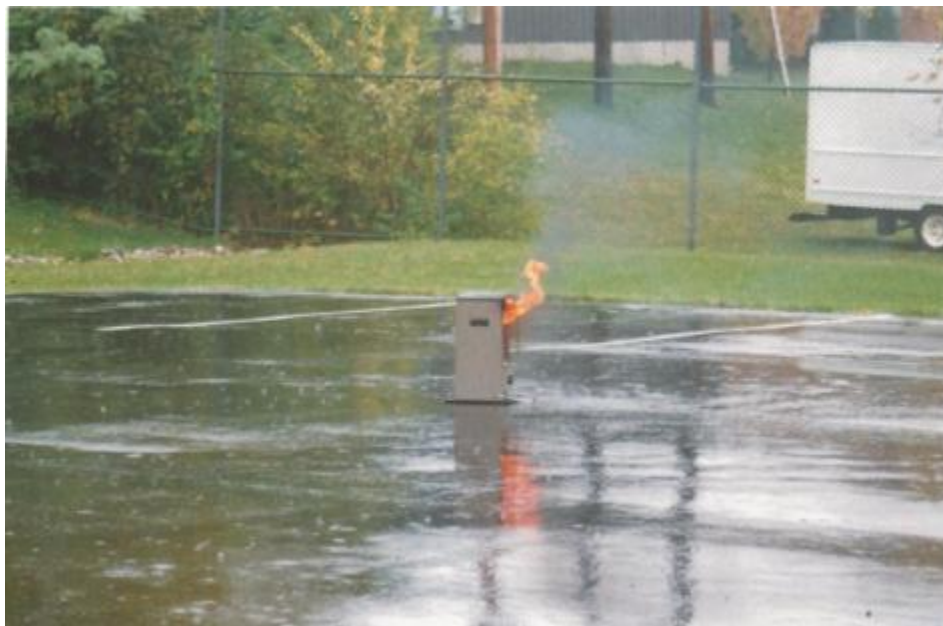
This photograph shows a rectangular-type kerosene heater being tested at my office while the Blue Ash Fire Department stood by. For this test, I poured one cup of kerosene and four cups of gasoline together into its gravity-fed fuel tank. Then I used an electric igniter while standing 100 feet away to ignite the kerosene. A video camera was started, and for one hour the kerosene burned normally.

Because gasoline is lighter than kerosene, the gasoline sat on top of the kerosene in the fuel tank until the kerosene was consumed. At that time, the gasoline ignited, and it continued to burn, as shown in the photograph, for 1 ½ hours.

For this test, I set the wick at its lowest setting to simulate the subject case in which a houseboat was destroyed and two others badly damaged. After the subject fire, the Cincinnati Fire Department found gasoline in the fuel tank of a similar kerosene heater located at the area of origin.

Another expert had stated that this was just a coincidence and instead blamed a short circuit in wiring eight feet away from the heater. Yet, he took none of this wiring as evidence. The case settled a few days after my test.
