“KEEPING PACE” -#78

BEARING FAILURE CAUSES VAN FIRE:

NO COPPER MELT ON NEON SIGN WIRING:

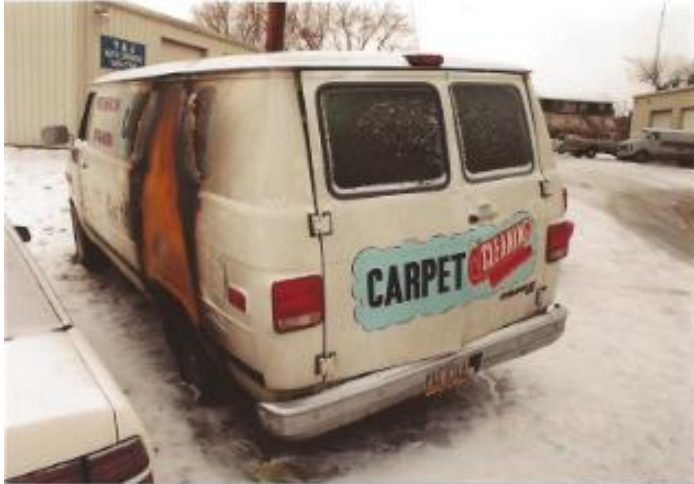
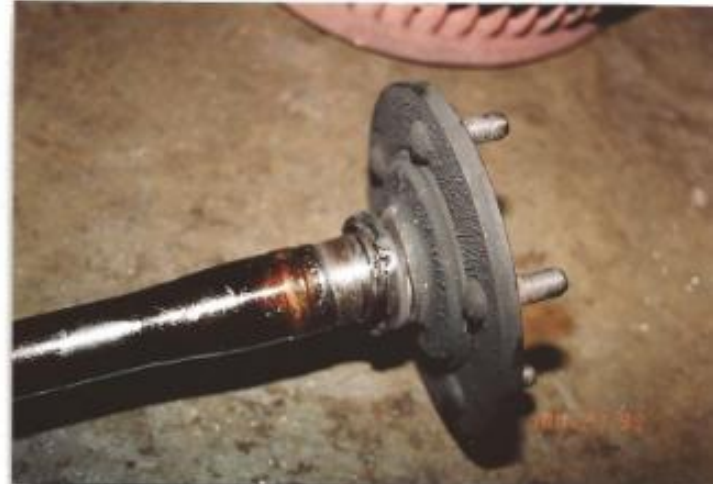
This van caught fire while it was being driven. When I first examined the van, I thought the driver had driven on a flat tire, which then ignited. I have seen this before in semi-truck tire fires. But the driver was adamant that he did not have a flat tire, so I removed the left, rear axle and found a failed bearing and a scored axle. The bearing is made of steel, and I have never observed the heat of a fire to melt steel, which melts at 2500° F. So there was no question that the bearing was the cause of the fire, because the fire could not have caused the bearing to fail.

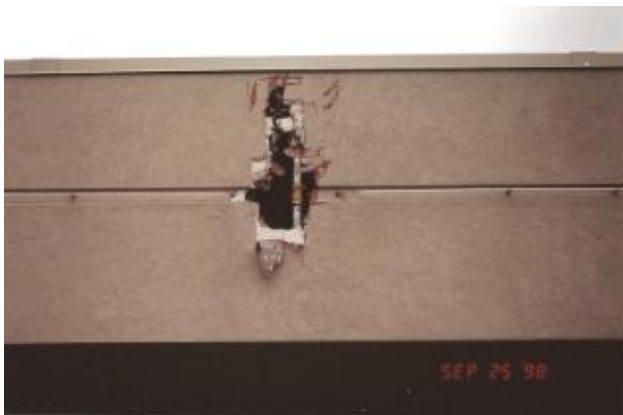
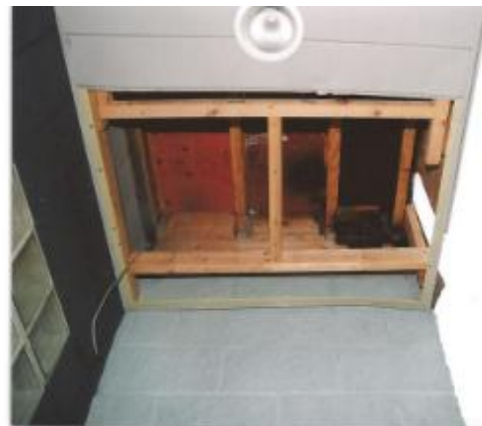
TWO SMALL NEON SIGN FIRES

One of the best learning tools for a fire investigator is fires of very limited extent. Such fires often have only one possible cause in the entire extent of the fire damage. The photographs above show two very small fires caused by short circuit arcs in neon sign wiring. I examined all the wiring in both cases, and I could find no copper melt on the wires, anywhere, even though an electrical arc had definitely caused the fire.

In neon sign wiring, the voltage is very high (15,000 volts), but the normal full load current supplied by the transformer to the neon tubing is only 0.03 amperes. Even during a short circuit arc, the current is limited to less than two amperes. This sometimes does not produce enough energy to melt copper, which melts at 1980° Fahrenheit.

These small fires prove that neon sign wiring can cause a fire without leaving any tangible evidence on the wires at all.
