“KEEPING PACE” - #83

UNANIMOUS PLAINTIFF JURY VERDICT:

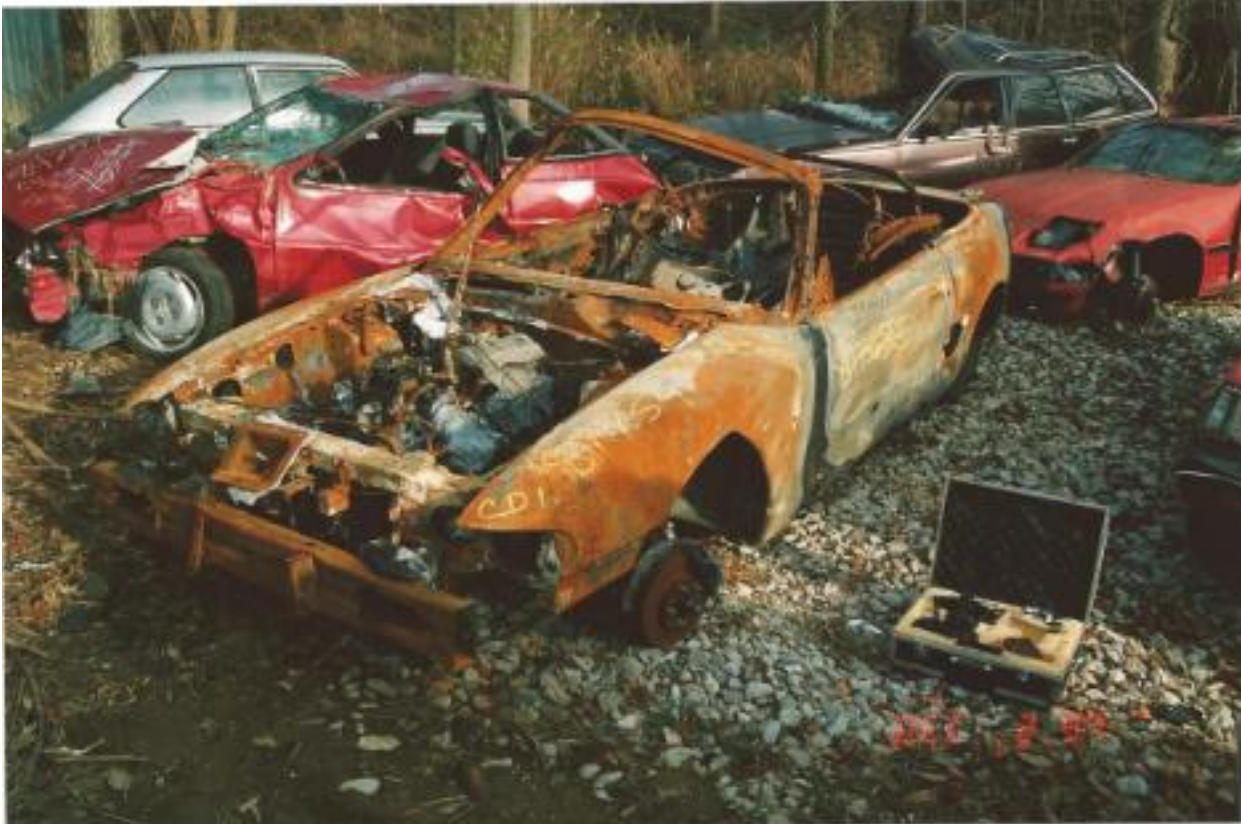
This vehicle was totally destroyed by the ensuing fire. The owner had seen flames at the right side of the engine compartment as he was driving it. This leased vehicle had only 4000 miles on its odometer, and it had never been serviced. I testified in court that no one can determine the cause of a fire in such total destruction by examining the burn patterns alone, because there are no meaningful burn patterns in such destruction.

But I went on to explain exactly how a short circuit arcing fire occurs, in spite of proper fusing, and how the arc can occur months (or years) after the wiring was damaged during manufacture of the automobile. (The engine had continued to run during the fire, essentially ruling out a fuel system problem.) I testified that whatever the exact cause, this was definitely a manufacturing defect.

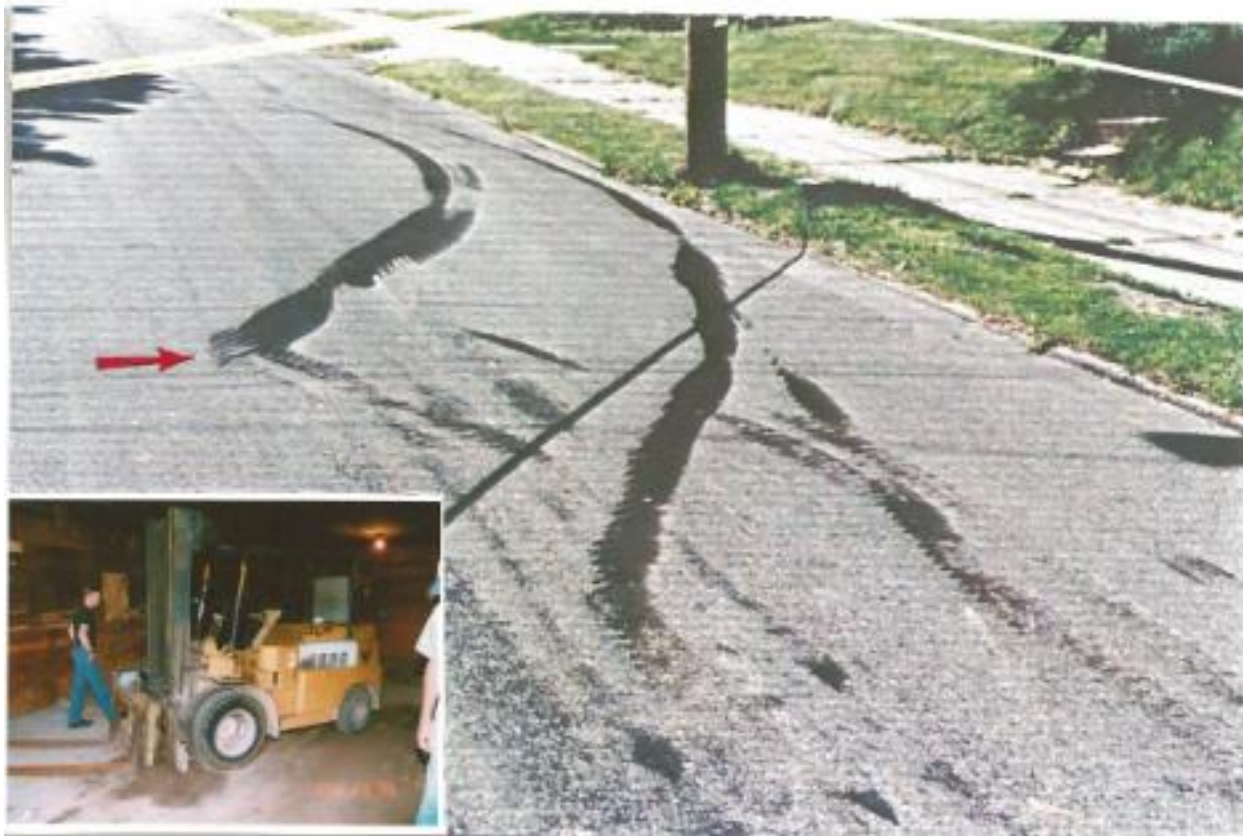
These tire marks were left by the forklift shown in the inset as it careened down this 12% grade on a city street, out of control. The driver had decided to drive this forklift across town, rather than transporting it on a trailer. A person following him saw the driver put the forklift in “Neutral” on this hill, to go faster. Because forklifts are only meant to be used on a level surface, they do not have a very strong braking system.

When the driver applied his brakes, the front tires on this forklift skidded over 90 feet to the point shown by the red arrow in the photograph, when it suddenly rotated. That threw the driver off, and the forklift ran over him, causing fatal injuries.

Afterward, I used my g-Analyst accelerometer to measure a maximum stopping force, μ , of 0.24 g for the forklift’s brakes. This is typical for forklifts. Thus, I opined that the lumberyard which owned the forklift was not responsible for the cause of this accident.
